Locomotive History – 45071

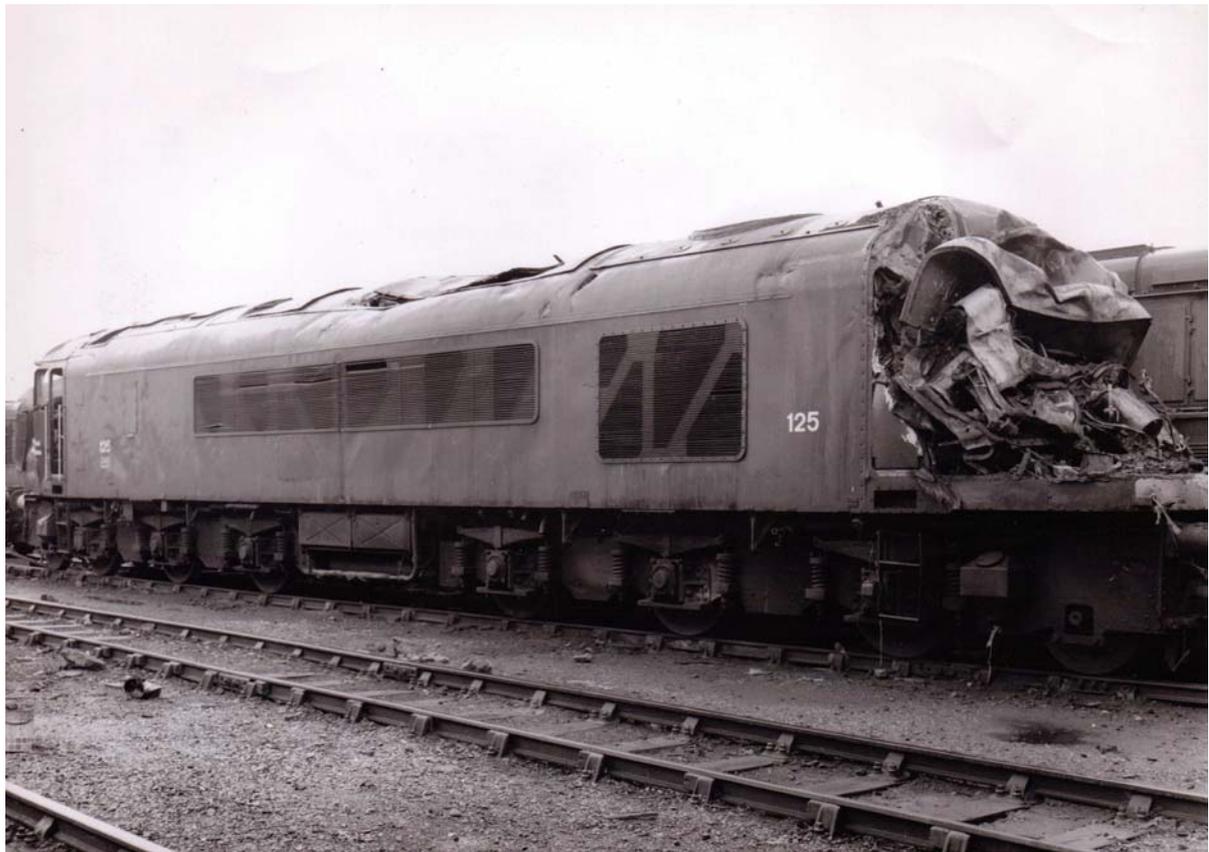
125 was seriously damaged at both ends, however the impact on the leading No.2 end cab was reduced by the cushioning effect of the fertiliser bags. The rear No.1 end cab was destroyed by 15 wagons behind the loco derailing and piling up, with one mineral wagon landing upside down on top of the rear cab. It was here that the guard unfortunately received fatal injuries. In addition, the loco body, frame and roof was distorted and the rear bogie displaced and

extensively damaged. Both Up and Down main lines were blocked by the wreckage of the wagons and some 240 feet of track was damaged.

125 stored at Derby Works in early 1975, showing the severely damaged rear cab.

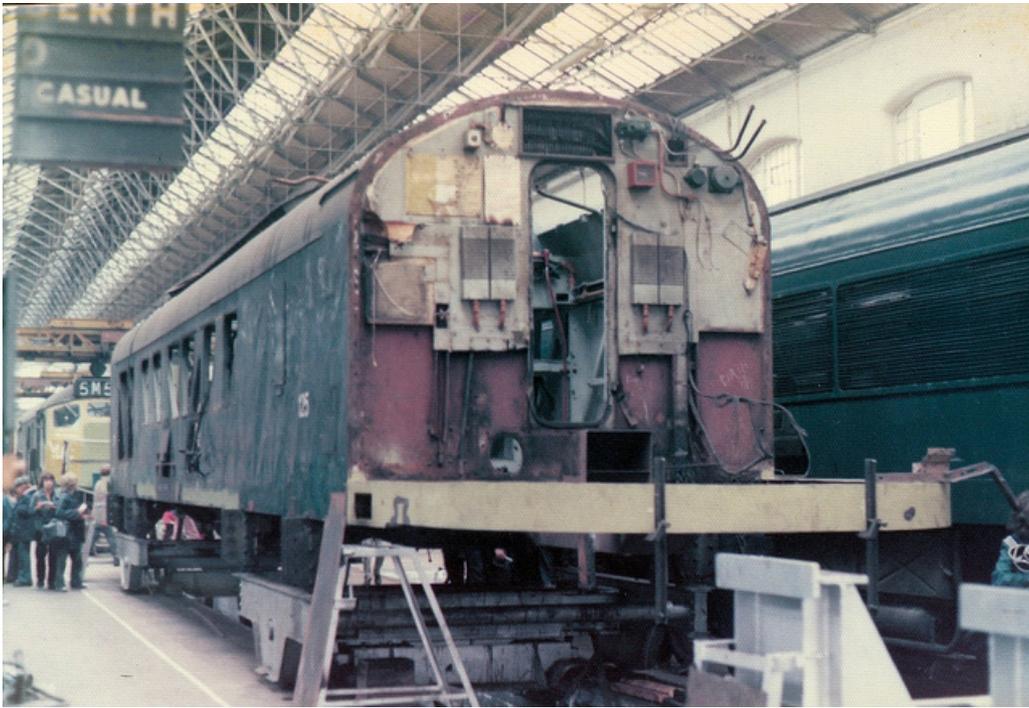
125 (45071) under repair at Derby Works in 1975

Following recovery, 125 was moved to Derby works where it languished for several months awaiting a decision on its fate. Eventually it was authorised for repair and emerged from Derby Works in December 1975 as 45071, the last

locomotive to receive its new number under the 1973 TOPS renumbering scheme. During this repair it was fitted with dual train brakes and became the first class 45 to have its headcode boxes (destroyed in the collision) replaced by a flush front end with marker lights. The style of marker light carried by 45071 was unique and thought to come from Class 20. 45071 continued in service until September 1981 when it was withdrawn with a power unit fault. It was sent to Swindon Works for storage and was broken up there in July 1983.

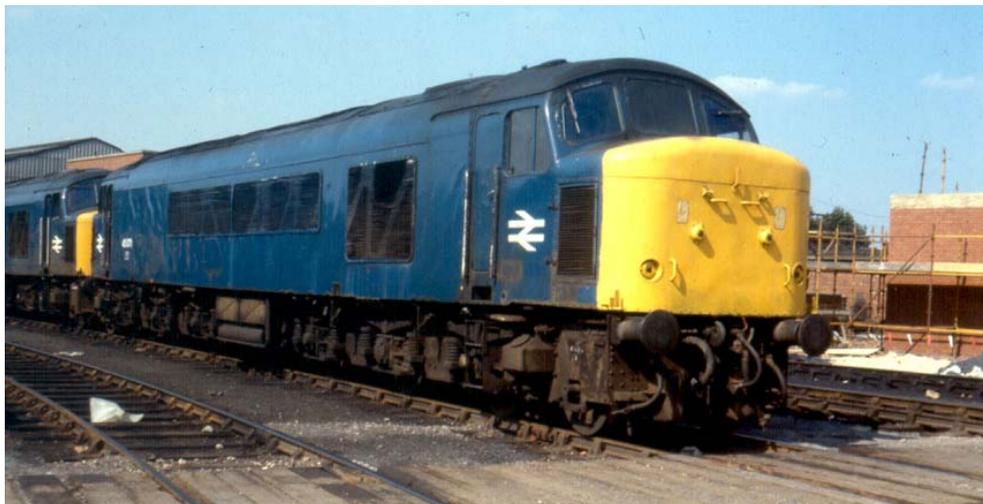
45071 shows off its new front end, with Class 20 style lights in 1976.
