D94 (45114) – serious collision at Stanton Gate on 6th December 1963

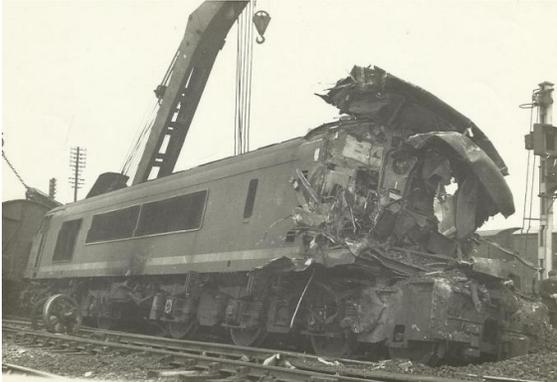
The damage to D94 was severe. Its nose and leading No.2 end cab were almost totally destroyed. The underside and trailing No.1 end received lesser damage. A small fire broke out on the leading battery box on the right-hand side in the direction of travel, but this was quickly extinguished by the Derbyshire Fire Service who had been called to the scene. The first six wagons of the train were derailed and damaged to a varying extent, but the remainder of the train remained on the track.
