Article – D94 (45114) Accident at Stanton Gate 06/12/63

(Photos were all taken by Mr Neville Berry and are reproduced by kind permission of his grandson, Andrew)

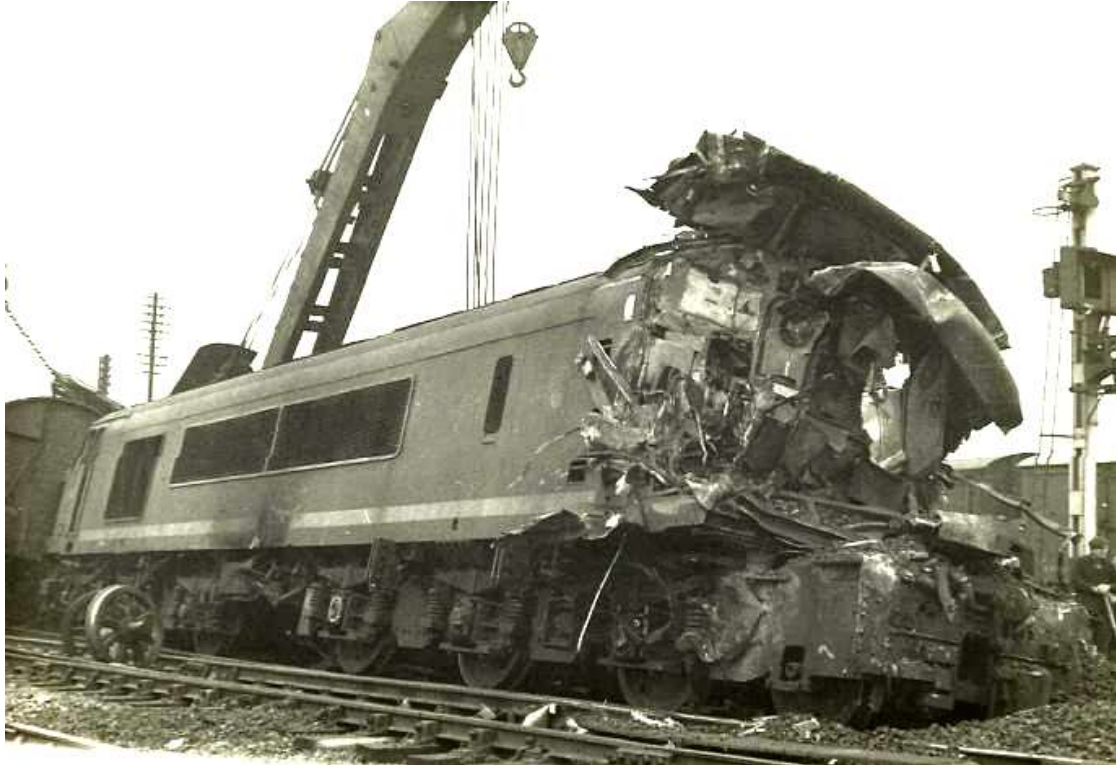
The damage to D94 was severe. Its nose and leading No.2 end cab were almost totally destroyed. The underside and trailing No.1 end received lesser damage. A small fire broke out on the leading battery box on the right-hand side in the direction of travel, but this

was quickly extinguished by the Derbyshire Fire Service who had been called to the scene. The first six wagons of the train were derailed and damaged to a varying extent, but the remainder of the train remained on the track.

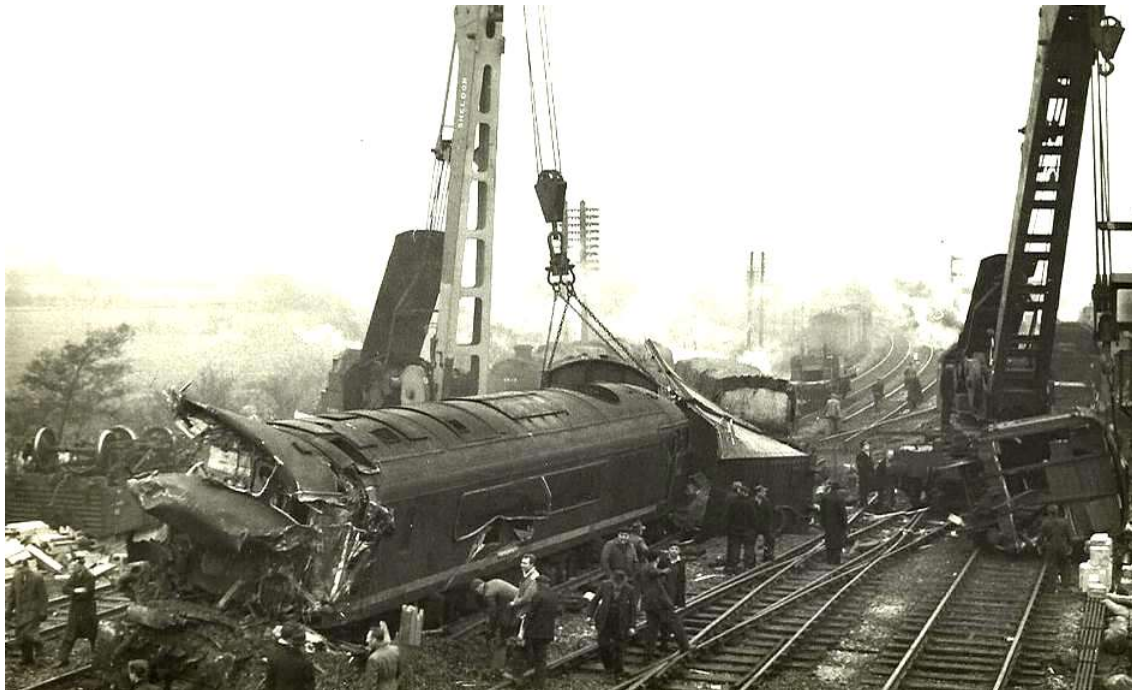
A careful examination was made as soon as possible after the collision to establish, as far as the damage would allow, the position of the controls when the collision occurred. In the leading cab the master control was found in the "off" position with the reversing handle in the forward position. The vacuum brake handle was found in the "full brake" position, but it is quite possible that, in the course of the destruction of the cab (during which the whole control desk was torn away from its surroundings), the handle could have been knocked out of the emergency position. As far as could be established, the brakes were in good working order and on both locomotive and train the brake blocks were found fully applied to the wheels.

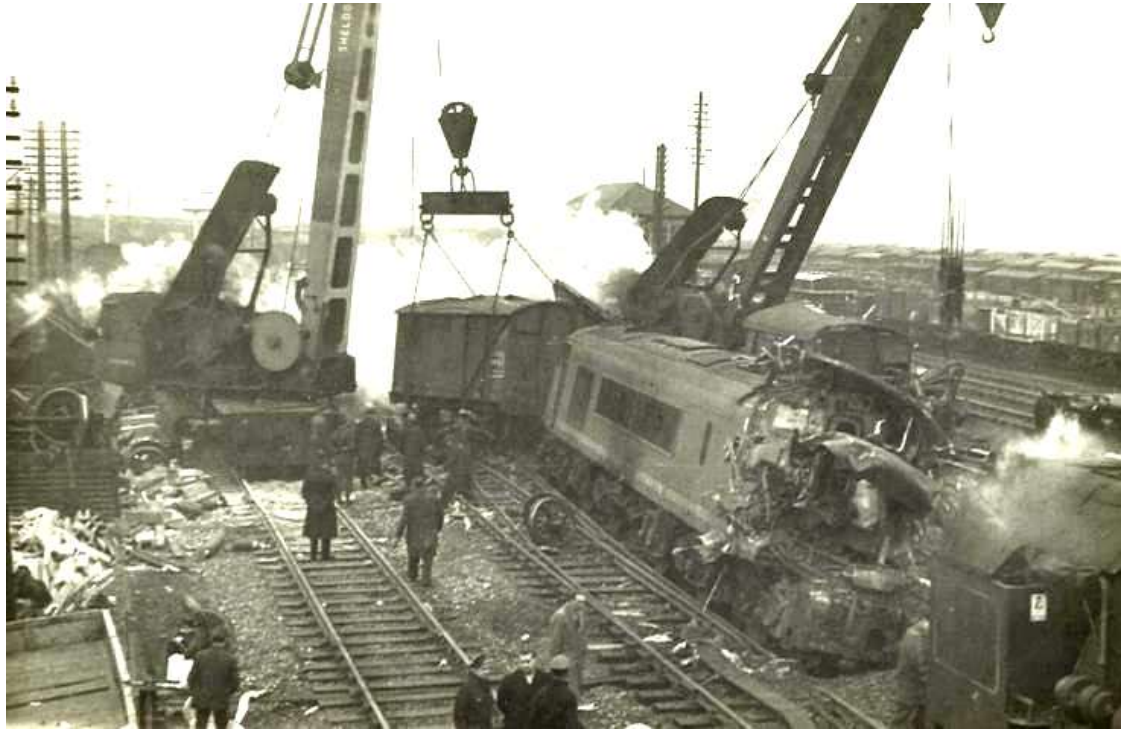
The line on which the collision occurred had not yet been provided with the Automatic Warning System (AWS) equipment, which would almost certainly have averted the collision, since if the driver had failed to react to a warning horn on approaching to the first distant signal at Caution, an automatic brake application would have followed. The report therefore recommended that it be fitted without delay!

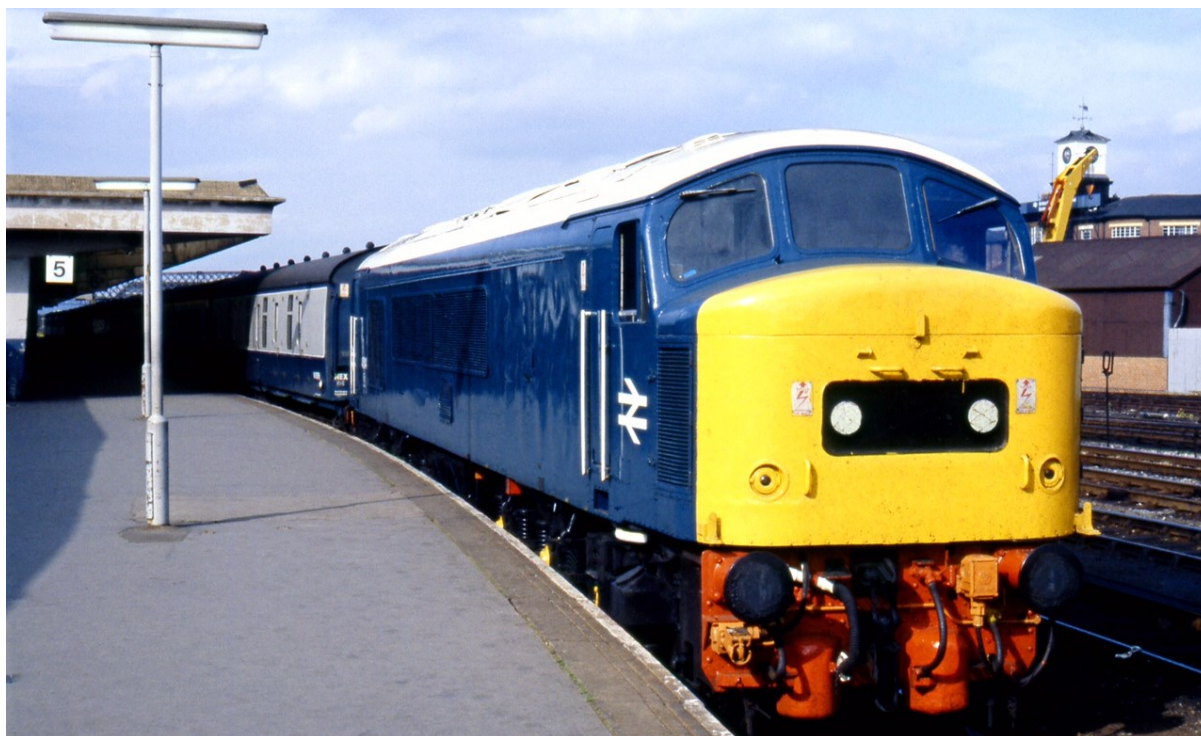
45114 sporting a white roof and red bufferbeams at Derby on 17/09/79.
