## **Article – D94 (45114) Accident at Stanton Gate 06/12/63**

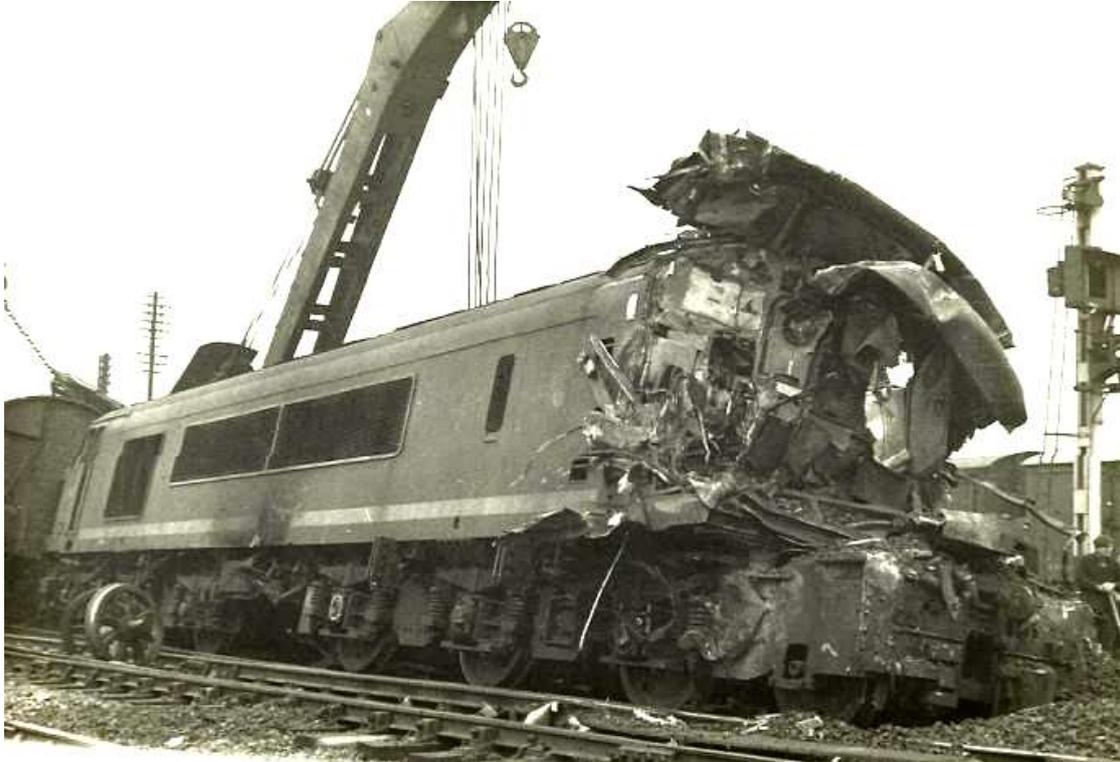
The damage to D94 was severe. Its nose and leading No.2 end cab were almost totally destroyed. The underside and trailing No.1 end received lesser damage. A small fire broke out on the leading battery box on the right-hand side in the direction of travel, but this

was quickly extinguished by the Derbyshire Fire Service who had been called to the scene. The first six wagons of the train were derailed and damaged to a varying extent, but the remainder of the train remained on the track.

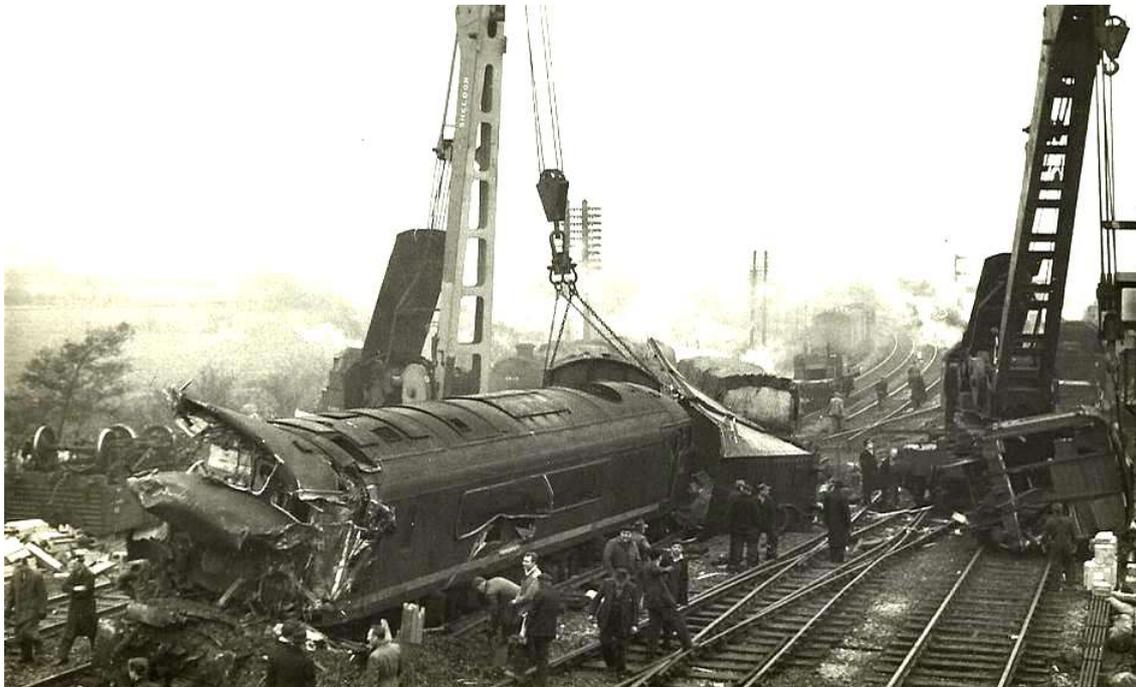
A careful examination was made as soon as possible after the collision to establish, as far as the damage would allow, the position of the controls when the collision occurred. In the leading cab the master control was found in the "off" position with the reversing handle in the forward position. The vacuum brake handle was found in the "full brake" position, but it is quite possible that, in the course of the destruction of the cab (during which the whole control desk was torn away from its surroundings), the handle could have been knocked out of the emergency position. As far as could be established, the brakes were in good working order and on both locomotive and train the brake blocks were found fully applied to the wheels.

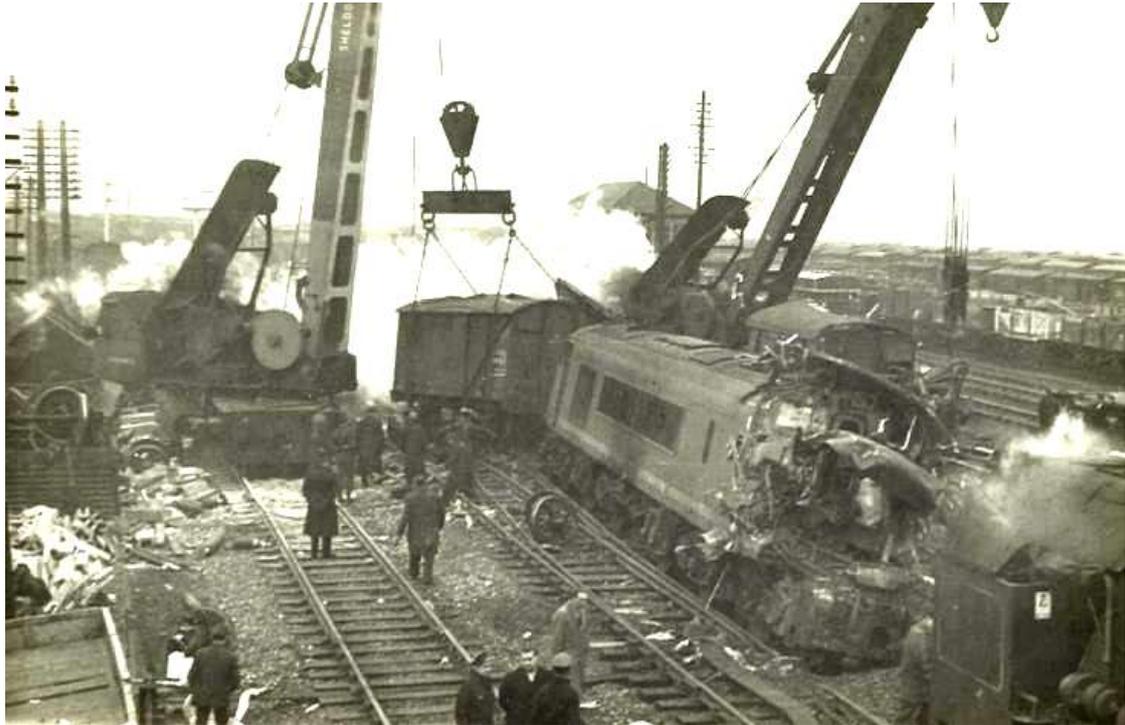
The report concluded that D94 was still under power and running at about 45 mph when it passed Stanton Gate North signal box, but owing to the unfortunate death of the train crew, it could only be speculated on what the conditions were in the cab and what led both men to become completely unaware that they were running into danger. From the position in which the controls were found it was apparent that the driver had, at the last moment, shut off power and made what was probably an emergency brake application.

The line on which the collision occurred had not yet been provided with the Automatic Warning System (AWS) equipment, which would almost certainly have averted the collision, since if the driver had failed to react to a warning horn on approaching to the first distant signal at Caution, an automatic brake application would have followed. The report therefore recommended that it be fitted without delay!
