45121

Class 158 hits a 'Peak'

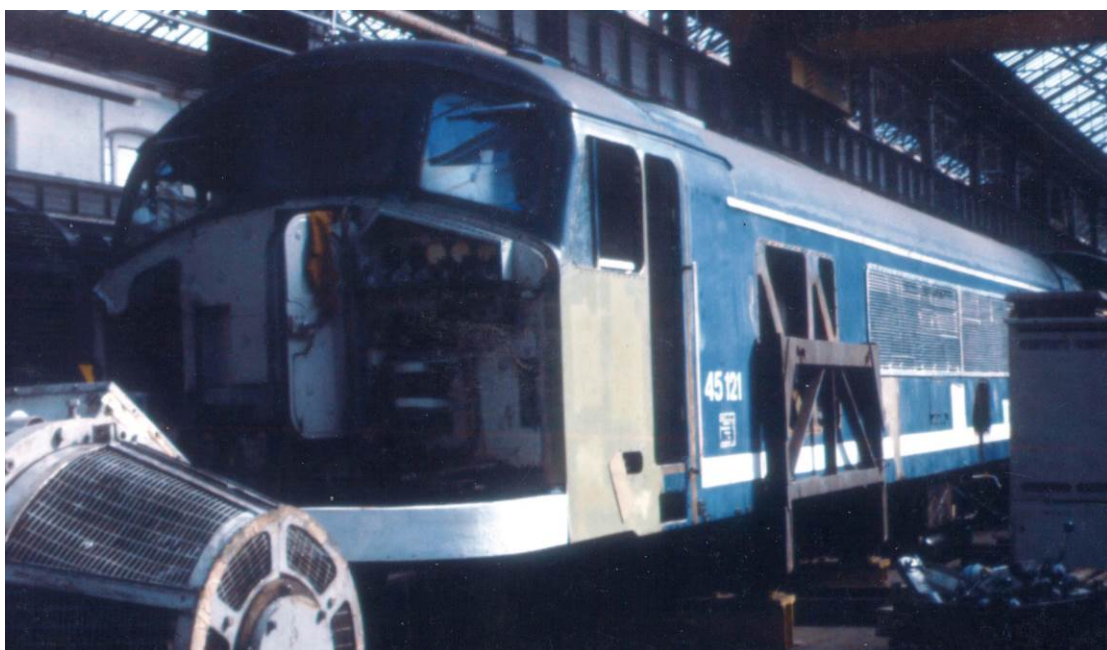
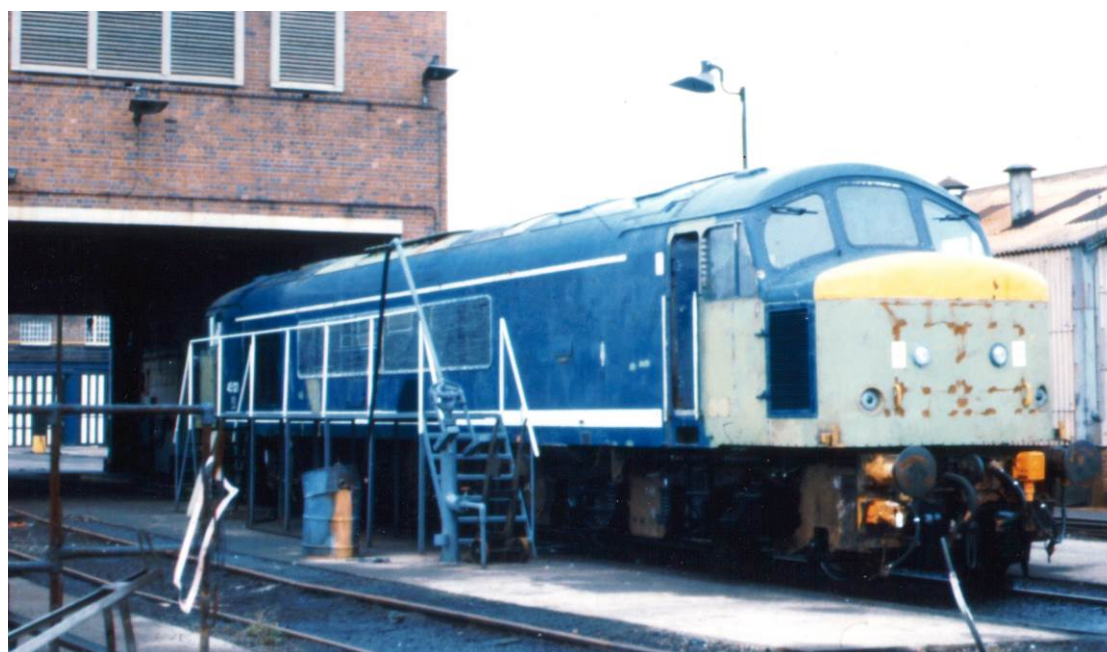
45121 (the erstwhile D18) was one of two Class 45/1s (the other being 45110) that received white body side stripes and red buffer beams at Toton Depot in 1980. The loco carried these in service until being called into Derby Works for a Heavy General Overhaul in 1981. The rare photos below show the loco in the Erecting Shop during refurbishment and outside the Test House just prior to repainting. Note that the head code boxes on the nose ends were also replaced with sealed beam headlights during this overhaul.

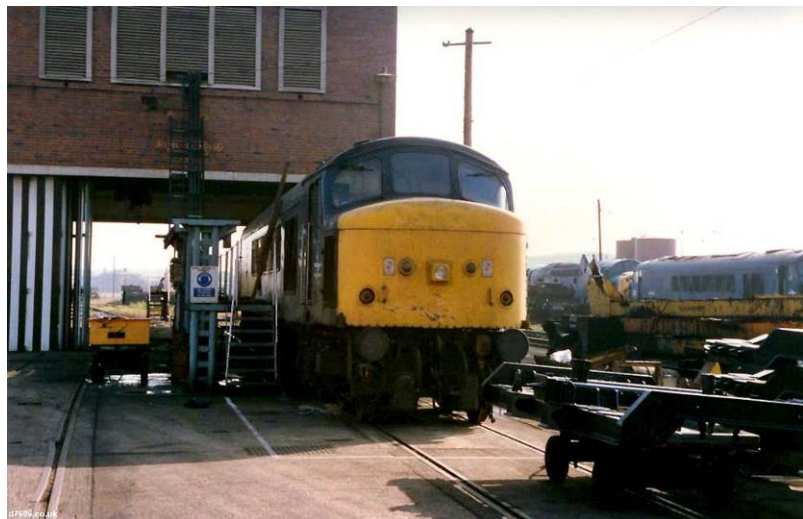
The loco made a final visit to the works in June 1986, being one of the last 45s to receive repairs there (photo below by Ian Hammond).

Following Main Generator Repairs it returned to traffic in October 1986.

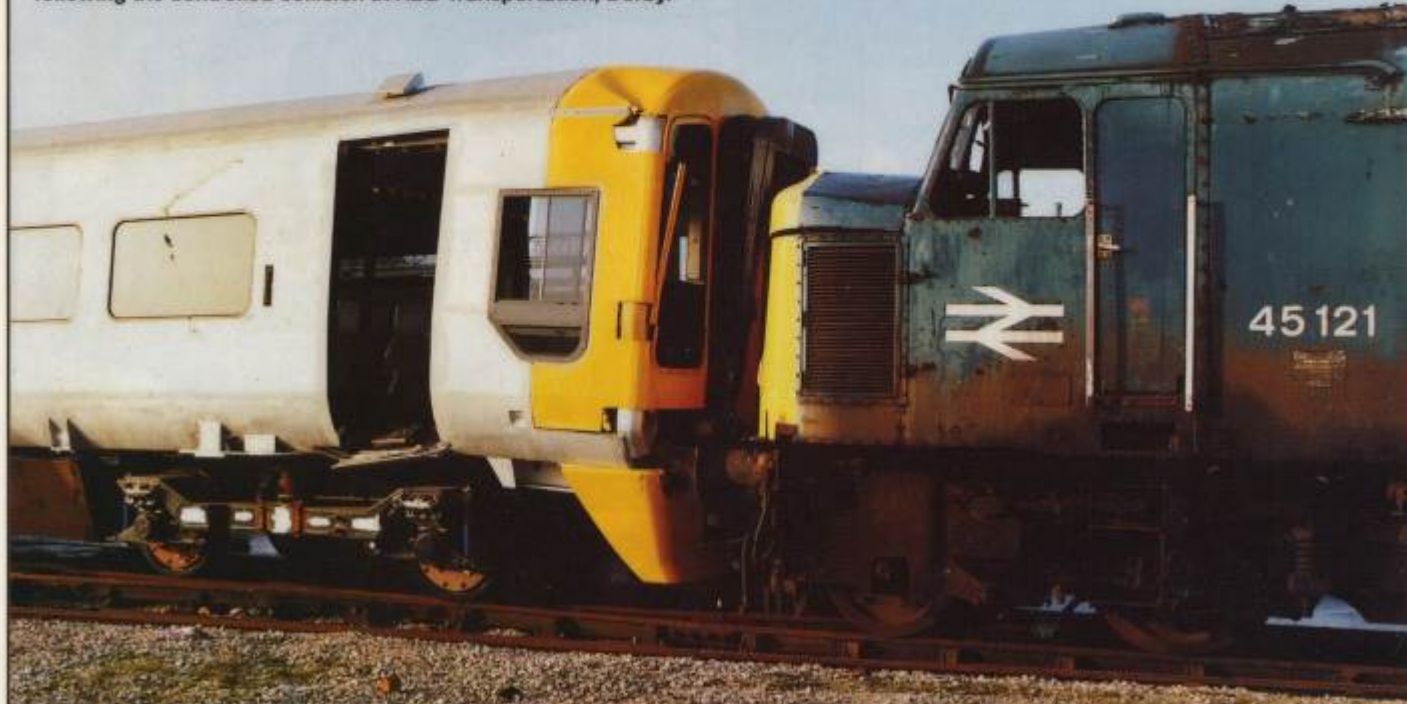
Locked together, the Class 158 vehicle and Class 45 No. 45121 following the controlled collision at ABB Transportation, Derby.

With the 158 up to the required speed the Class 20 ceased accelerating and the unit charged into the locomotive. Initially the front of the Class 158 bounced up, allowing all wheels on the leading bogie to spin before making contact with the track again and pushing the Class 45, with all wheels locked, eleven metres along the track.

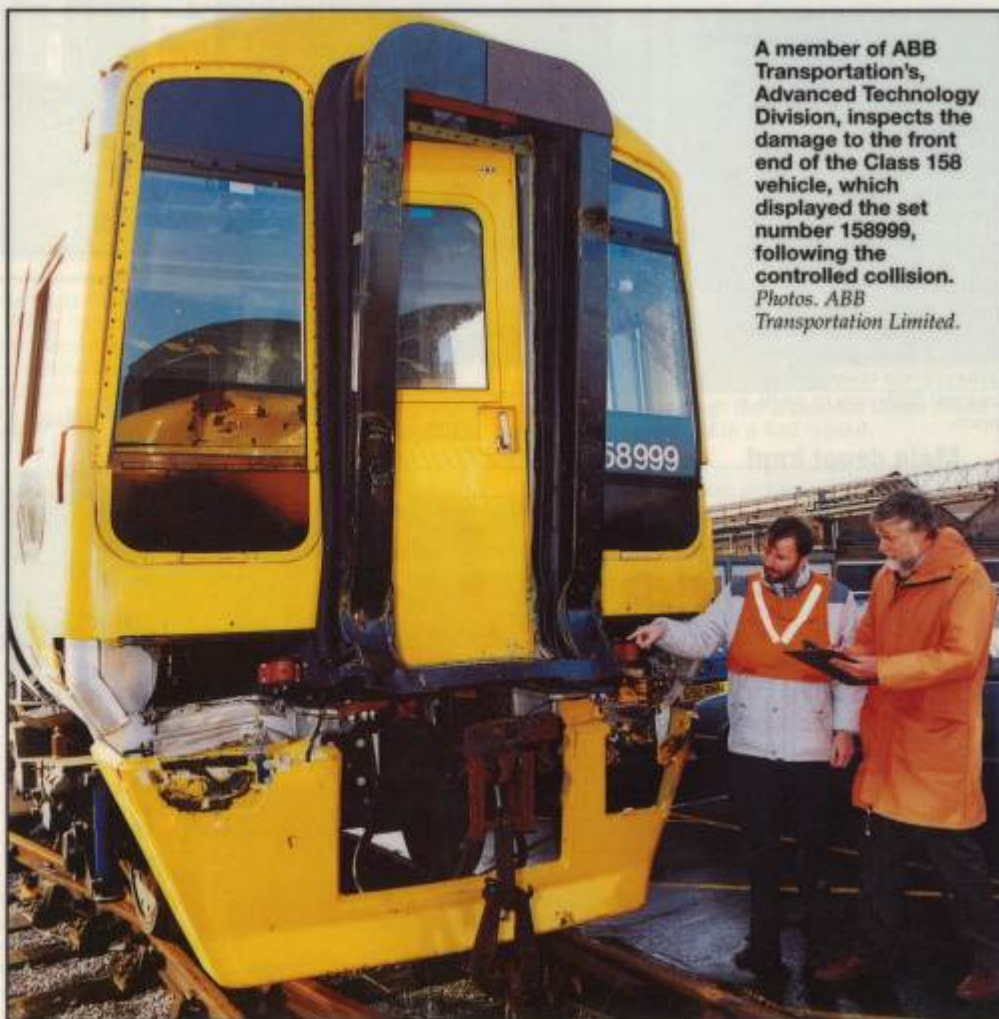
Severe damage to the 158 was confined to the lower front end and underframe equipment. The passenger compartment remained intact with no broken windows and the three dummies recorded survivable loads.

A member of ABB Transportation's, Advanced Technology Division, inspects the damage to the front end of the Class 158 vehicle, which displayed the set number 158999, following the controlled collision. Photos. ABB Transportation Limited.

The object of the exercise was to investigate the potential to improve vehicle safety, and demonstrate body repair procedures for aluminium vehicles following accident damage. The next task is to develop and apply repair procedures to the damaged 158 vehicle to demonstrate that, following repairs, the vehicle structure is as good as new. ●
