45147 Remembered

45147 was involved in an accident on 4th December 1984, resulting in the worst damage to ever be inflicted on a peak whilst in service. This resulted in the premature withdrawal of the loco, which became the first Class 45/1 to be scrapped. This article was first written several years ago, but the content has been revised in 2024 with new information and photos to chronicle the loco's history and details of its untimely demise.

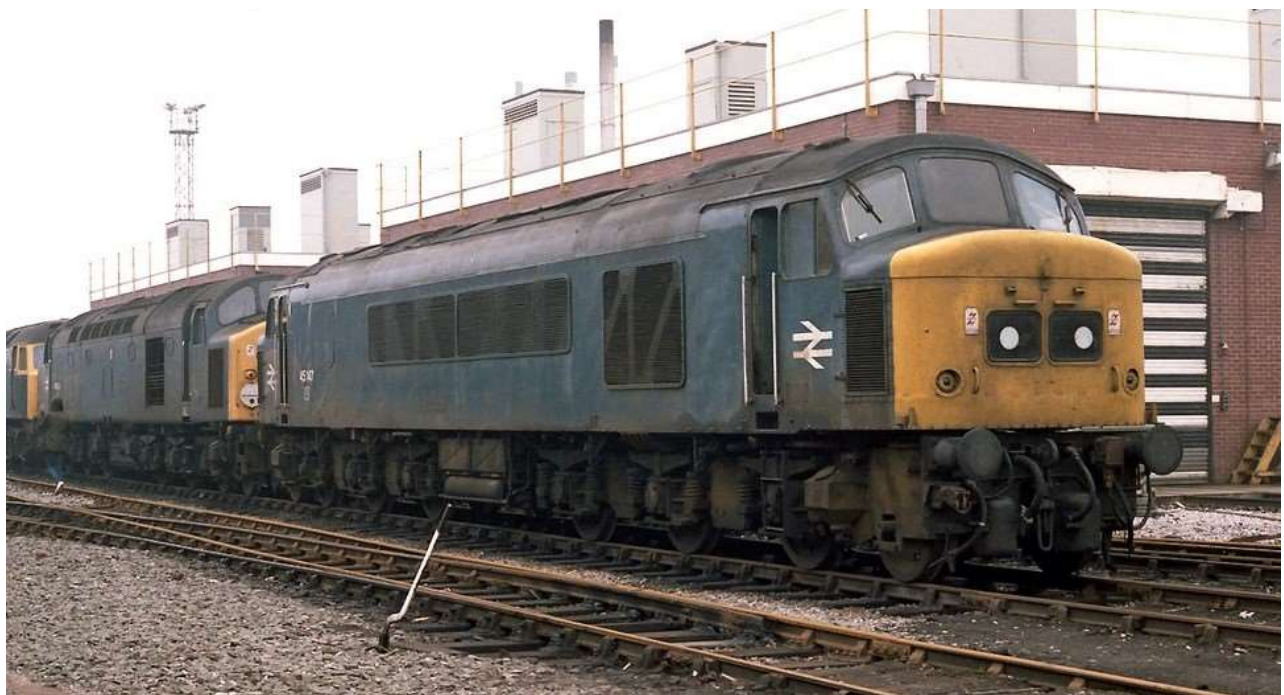
Having entered Crewe Works for a Heavy General Overhaul during the second week of June 1982, 45147 spent several weeks in the yard outside before entering the workshops. It is noted here in the works yard on 1st August 1982.

Unlike Derby Works, who used to remove the nose ends for removal of the headcode boxes and fitting of sealed beam marker lights, Crewe would cut out the headcode boxes with the nose end still in situ and then plate in new steel for fitting of the lights. When this was done to 45147, all the nose end fittings were removed (including the handrails next to the tail lights!), except the centre lamp bracket at No.1 end!

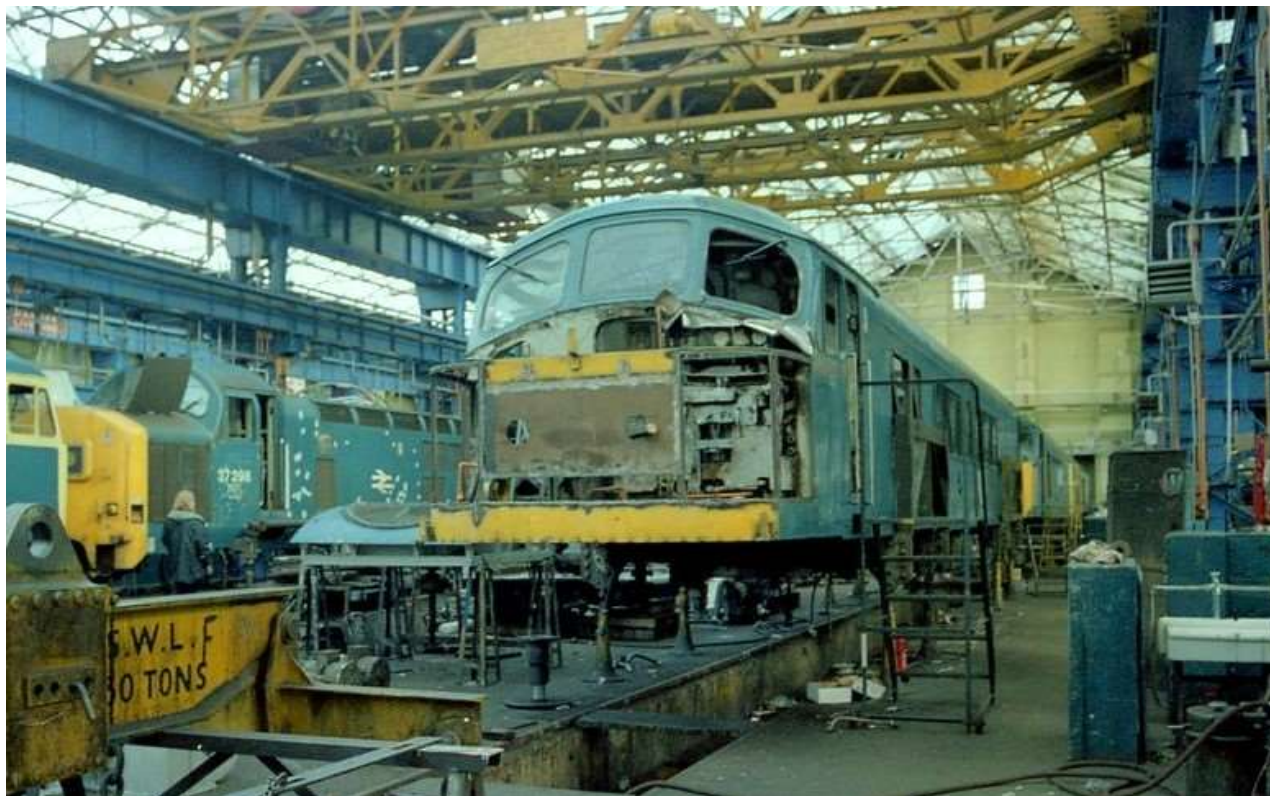
45147 is seen here inside Crewe Works on 26th September 1982, showing the nose end steel work removed from No.1 end and a new piece of metal welded in to replace the head code boxes with marker lights. Note the single centre lamp bracket left in place just above the new steel. Photo: Stephen Widdowson

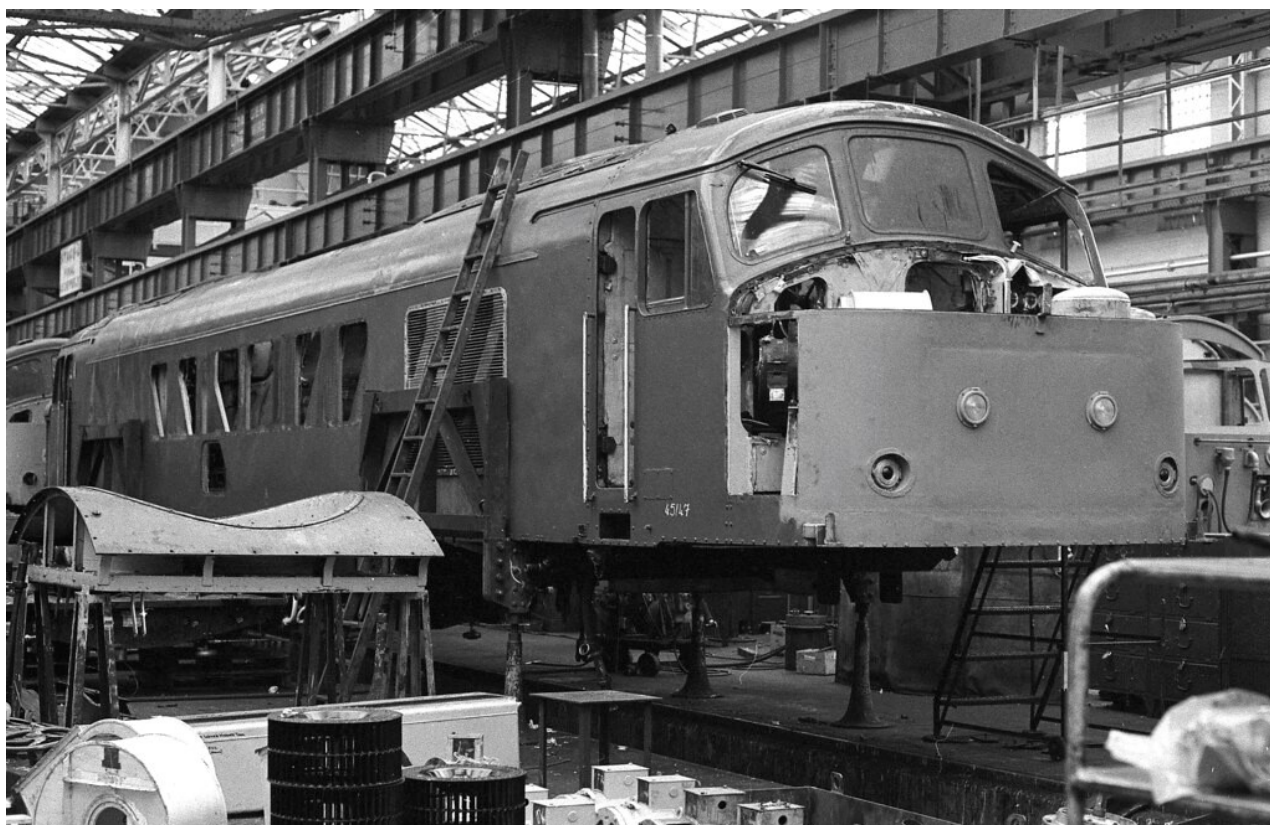
In this photo taken on 17th October 1982, reconstruction of the No.1 end nose is nearly complete. However, the small handrails by the tail lights have not been replaced and the centre lamp bracket is still in place at the top. Photo: Kevin Connolly

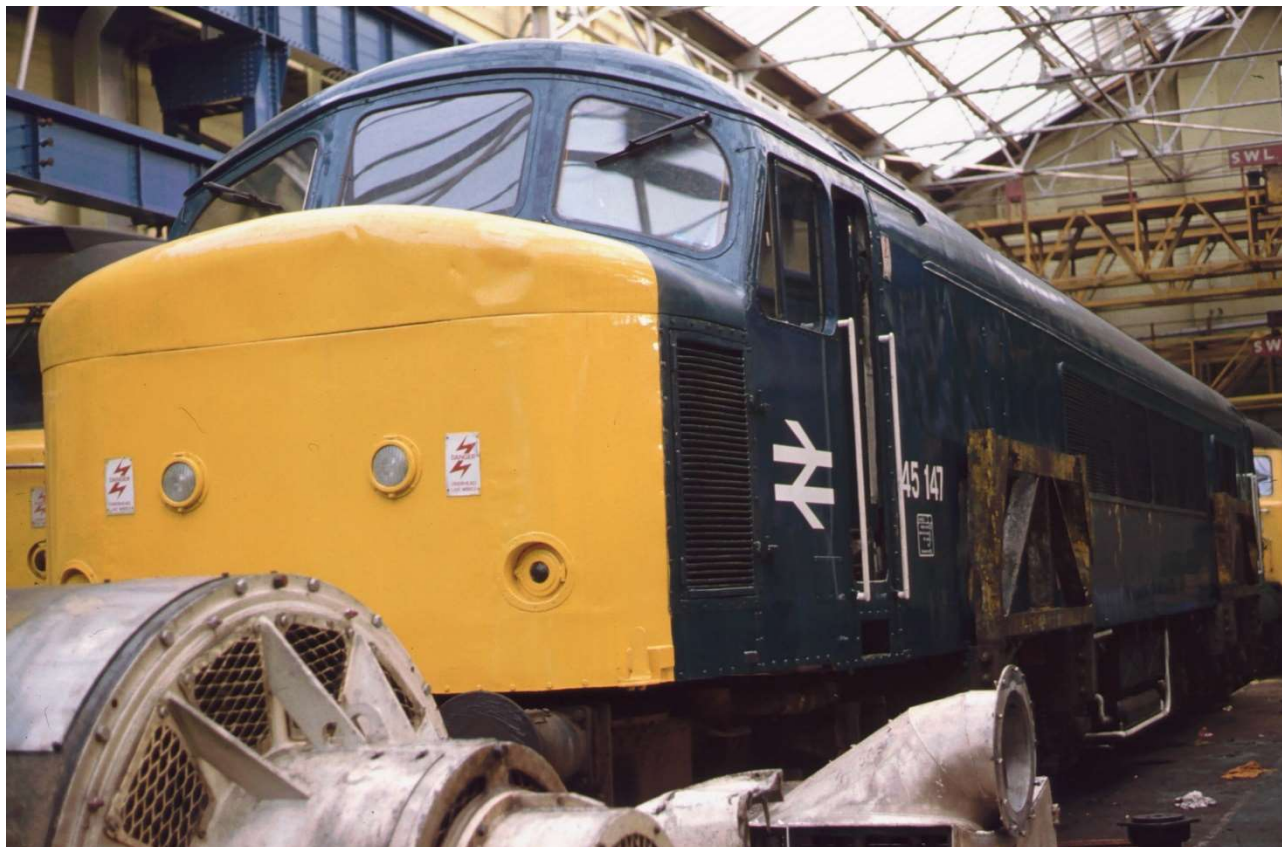
At the No.2 end of the loco, reconstruction was done in the same way, but the centre top lamp bracket was also removed, as seen here when the overhaul was nearly complete in January 1983. Photo: Eric Lonie

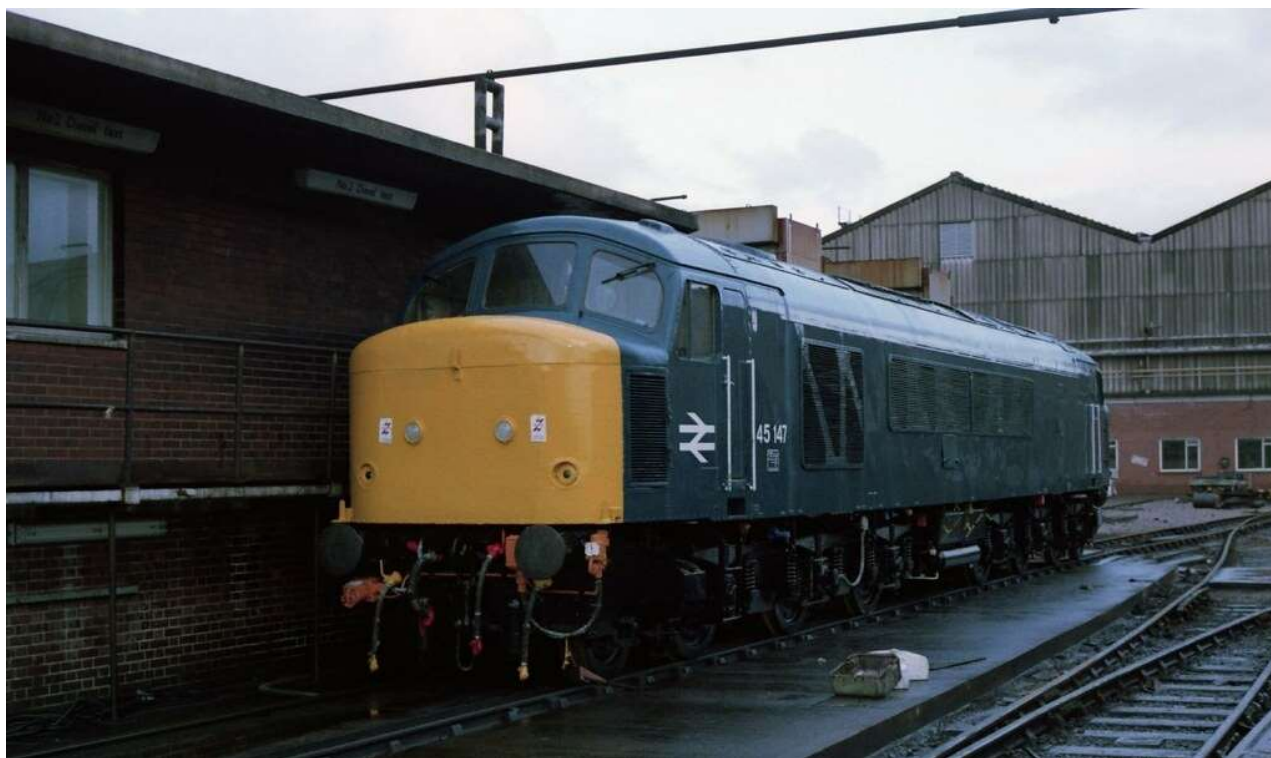
45147 undergoing static testing following overhaul at Crewe Works in January 1983, prior to main line testing. Photo: John Ashton

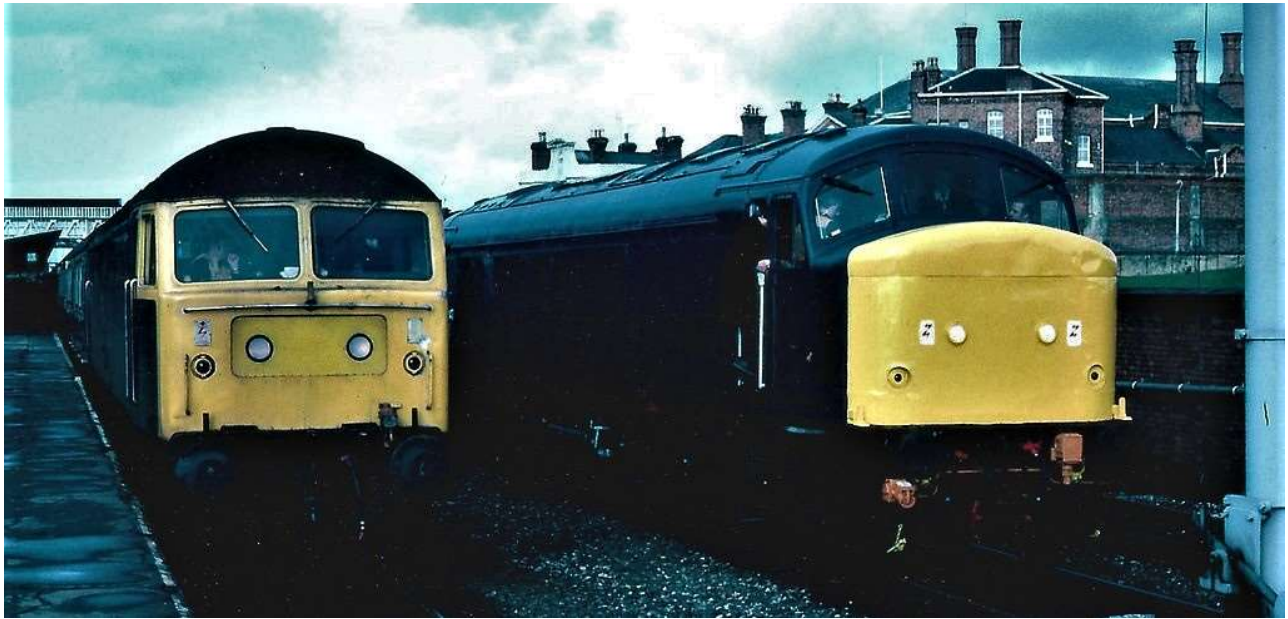
45147 can be seen at Shrewsbury on 14th January 1983 during its first test run from Crewe Works. Note that the leading No.2 end does not have the upper lamp bracket fitted. Photo: Steven Clements.

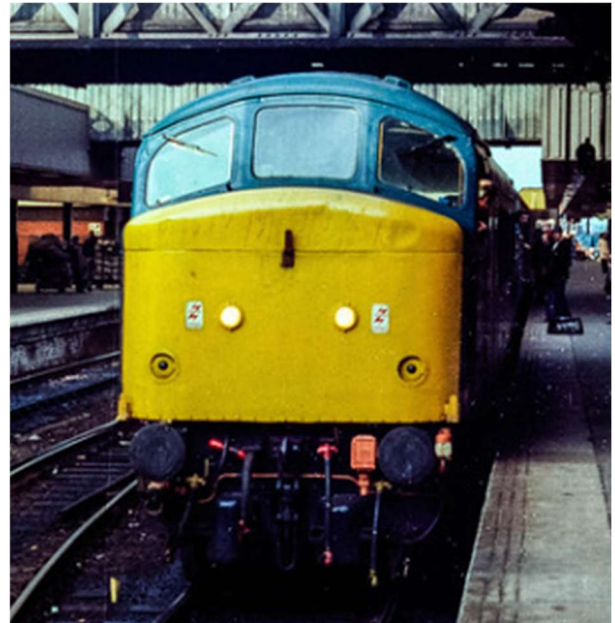
45147 seen at Leicester in April 1983, with the additional lamp bracket now fitted at No.2 end to match the other end.

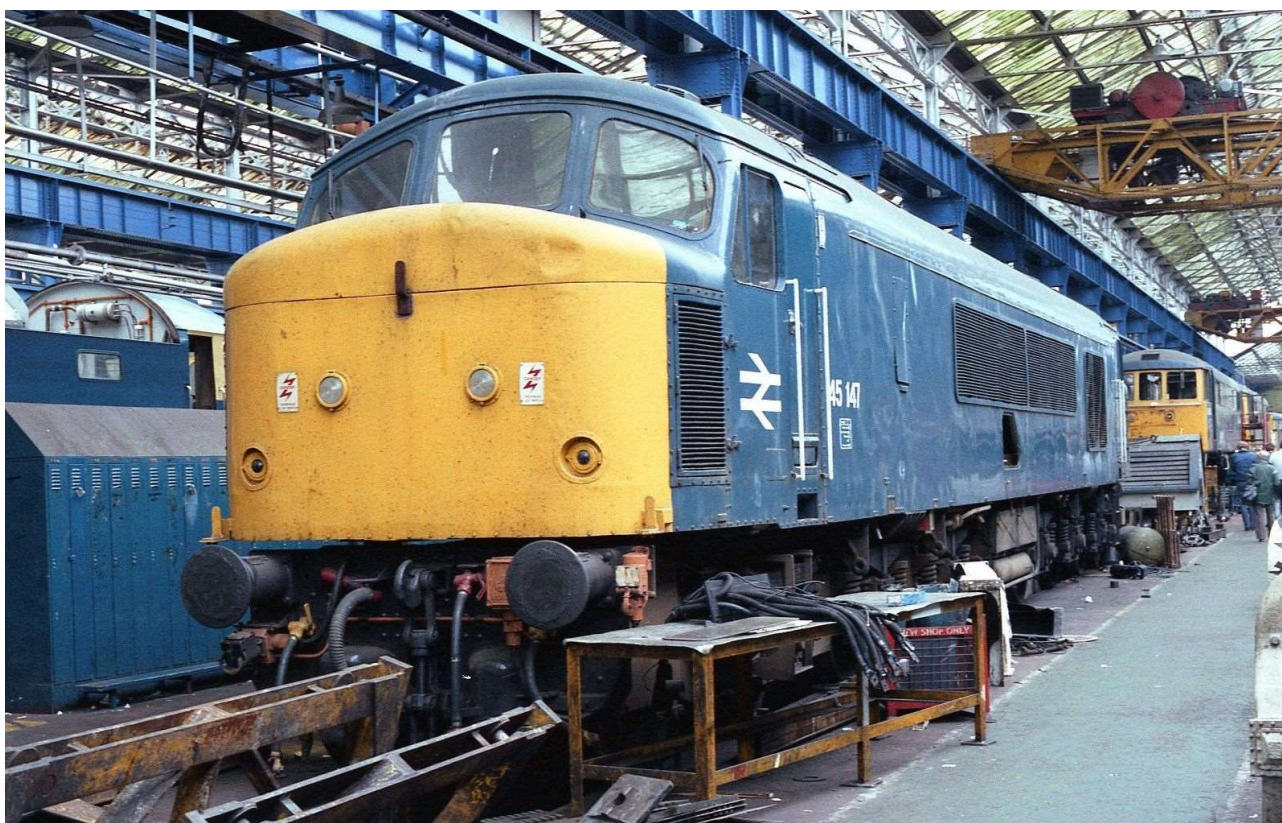
45147 undergoing rectification work inside Crewe Works on 25/09/83

Crewe must have decided to keep the loco to sort out the problems once and for all, as it remained at the Works for the next 4 months, being noted there on 04/07, 29/07, 31/07, 29/08, 25/09, 04/10 and 30/10/83. The loco was finally returned to traffic in the first week of November 1983 and at last seemed to operate reliably after that.

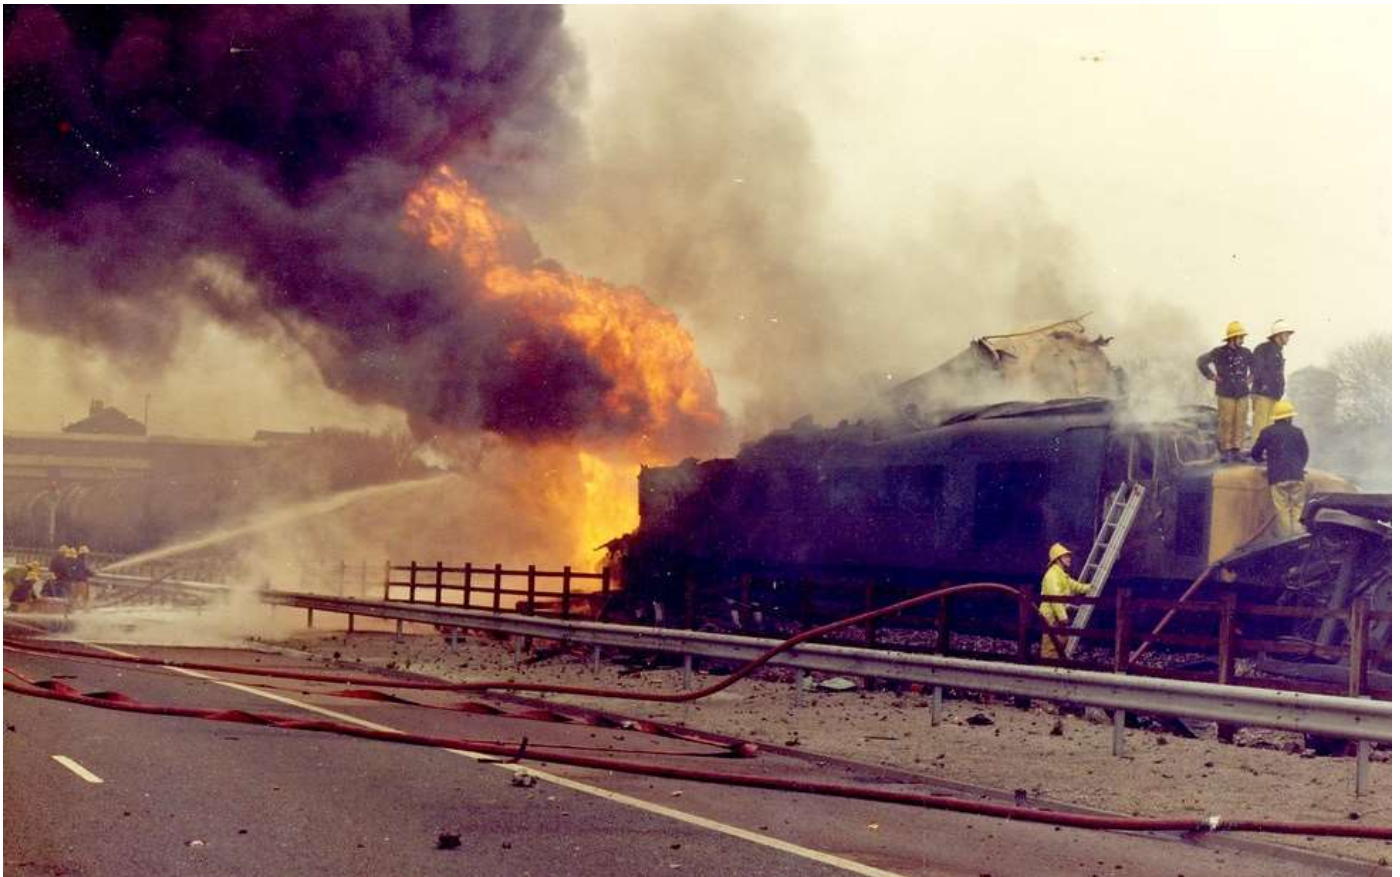
Above: The intense fire at the front of 45147 is tackled by the GMC Fire Service using foam compound. It took over an hour for the fire to be extinguished.

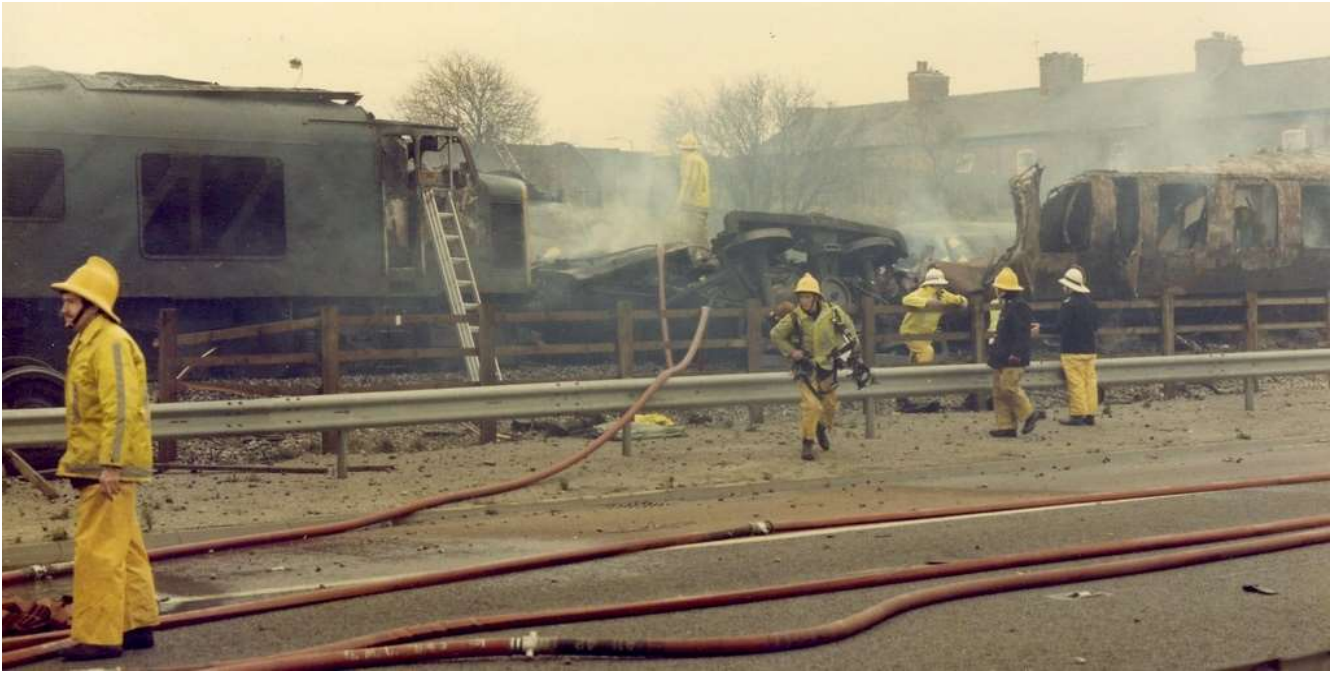
Above: The rear cab of 45147 and the remains of the leading Mk1 coach No. E3603. The front half of the coach body has been completely destroyed and the whole coach gutted by fire. A bogie from a tank wagon can be seen lying against it.

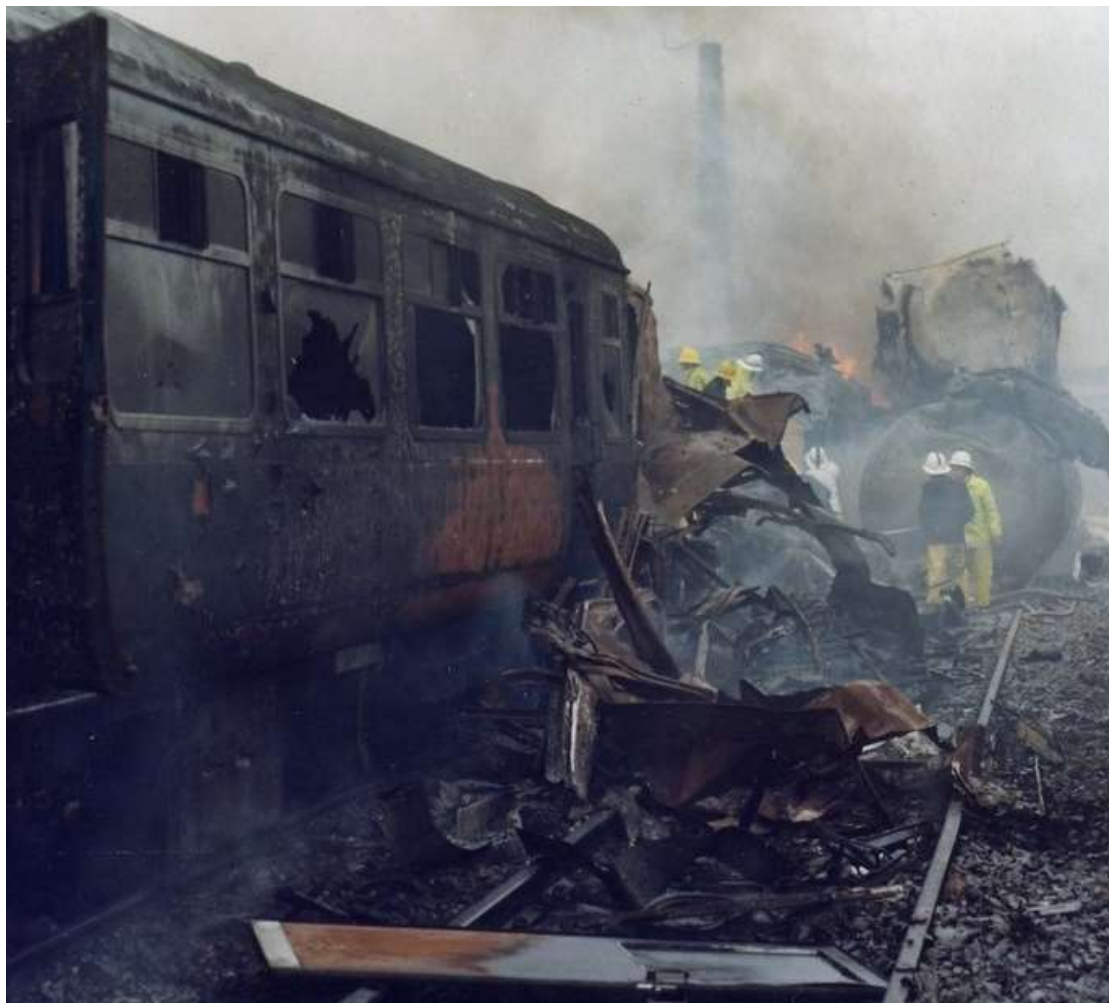
Above: The scene looking from alongside the second coach of the Scarborough train (MK2 No.E5289), past the wreckage of the leading coach, to the crushed rear cab of 45147, where the fire fighters are in the centre.

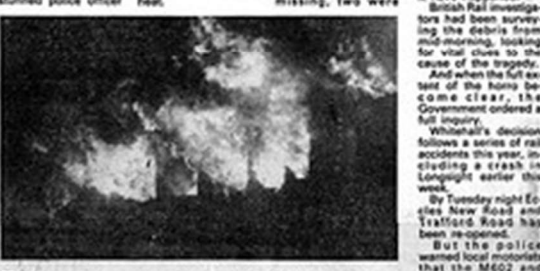
The first passenger carriage engulfed in flames and black smoke.

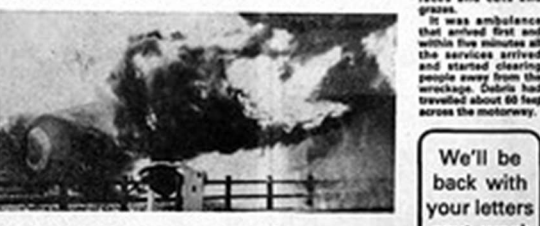
The blazing tanker lies across the track.

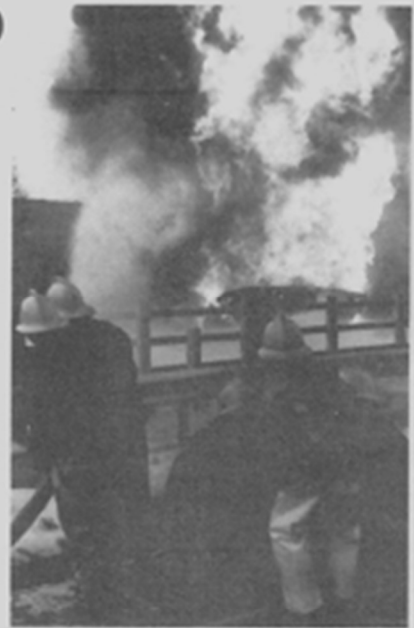
The Shell Company made arrangements to empty the tank wagons into a fleet of road tanker vehicles and whilst this operation proceeded, the Brigade maintained a foam blanket over the whole incident site. High expansion foam was used to good effect to seal off the area around a third tank wagon which had ruptured and discharged approximately half its contents around the incident.

The amount of fuel spilled resulted in large quantities, estimated to be in excess of 1,000 gallons, running into the surface drains of the motorway which subsequently discharged into the Manchester Ship Canal, approximately half a mile away. As a result, it was necessary for tests to be carried out on the Canal to establish that there was no danger of a second incident occurring. However, this contamination was sprayed with oil dispersant by the Ship Canal Company and the risk dissipated.

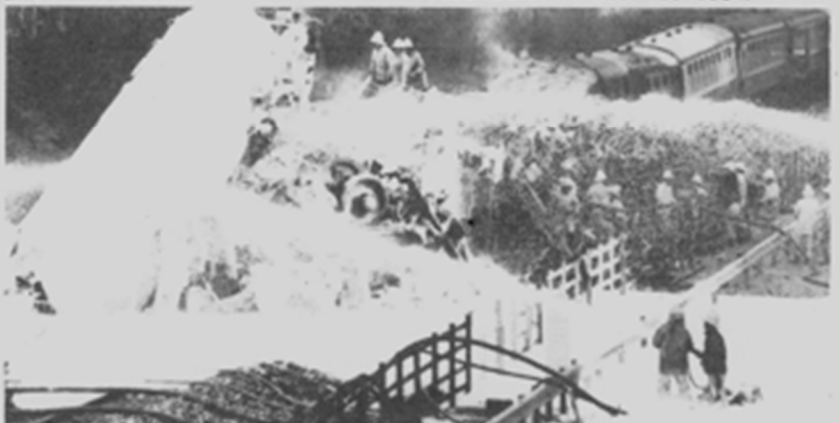
The driver's air brake control from 45147's leading cab was found on the motorway. Subsequent tests showed that the controls were working correctly and that the lever was in the full emergency brake position. It could not be proved, however, that the lever had not been moved to this position after the collision when it was ejected from the cab and struck the motorway. Tests on the coach brakes also showed that these had all been working correctly and evidence from the Scarborough train's guard that the train juddered severely before impact, indicated the emergency brakes were working well.

Oil was found on the track behind the passenger train, probably spilt from a gear case on 45147 and indicated the start of heavy braking. This, together with skid marks on the rails suggested that 45147 was just 120m from the rear of the oil train when the emergency brakes were applied and was travelling at approximately 45mph at the point of impact.

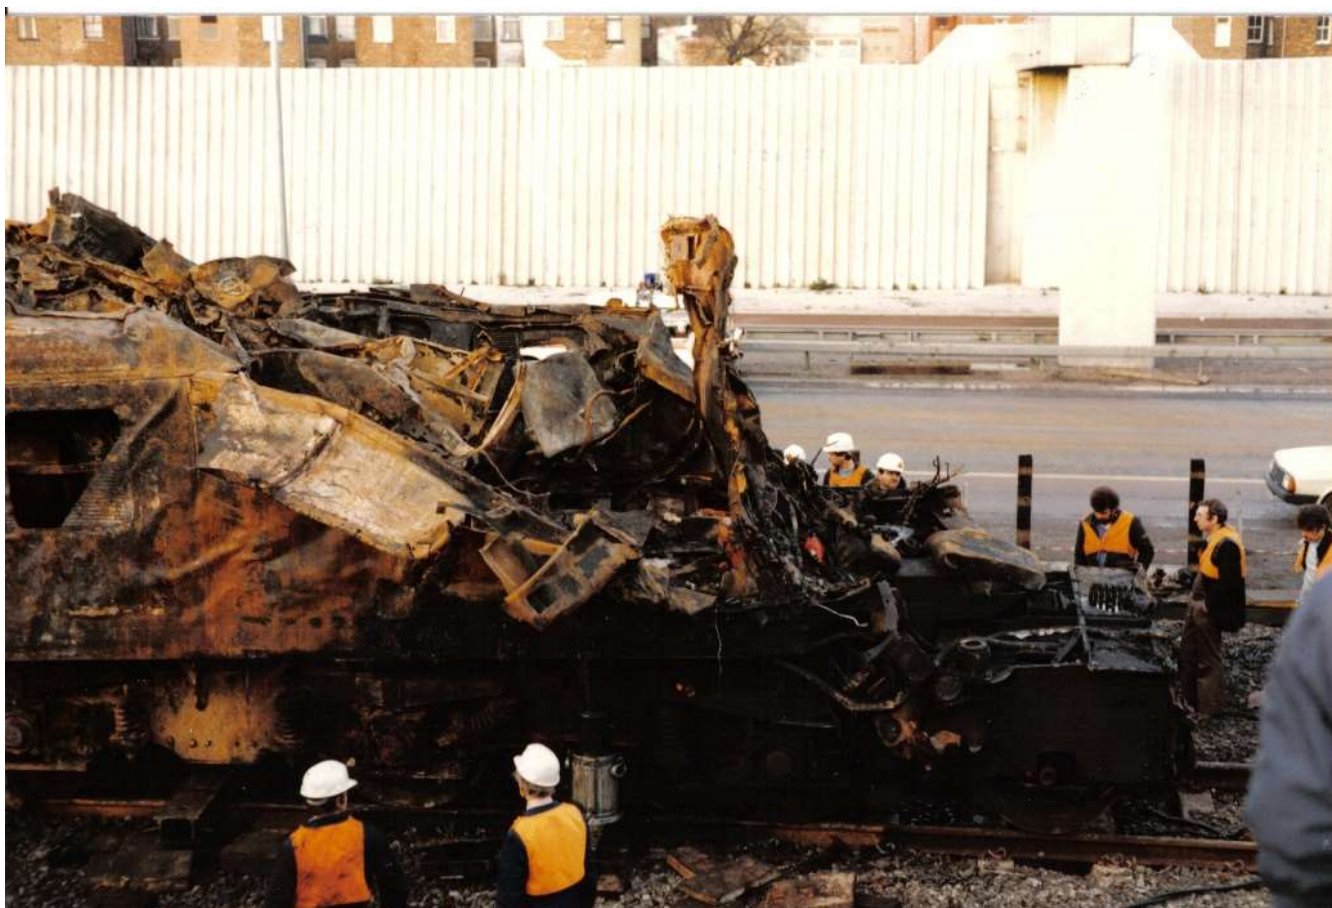
The front end (no.2 end) of 45147 was completely destroyed and the cab bulkhead driven almost horizontal into the engine compartment, although both bogies remained largely intact. The roof of no.1 end cab was also crushed by a derailed tank wagon and almost the entire loco, the rearmost three tank wagons, and the first passenger coach were engulfed in a ferocious fire. This was probably caused by escaping gas oil being ignited by 45147's hot exhaust.

Above: The completely destroyed leading No.2 end of 45147 seen during recovery operations. Photo: F J Bullock

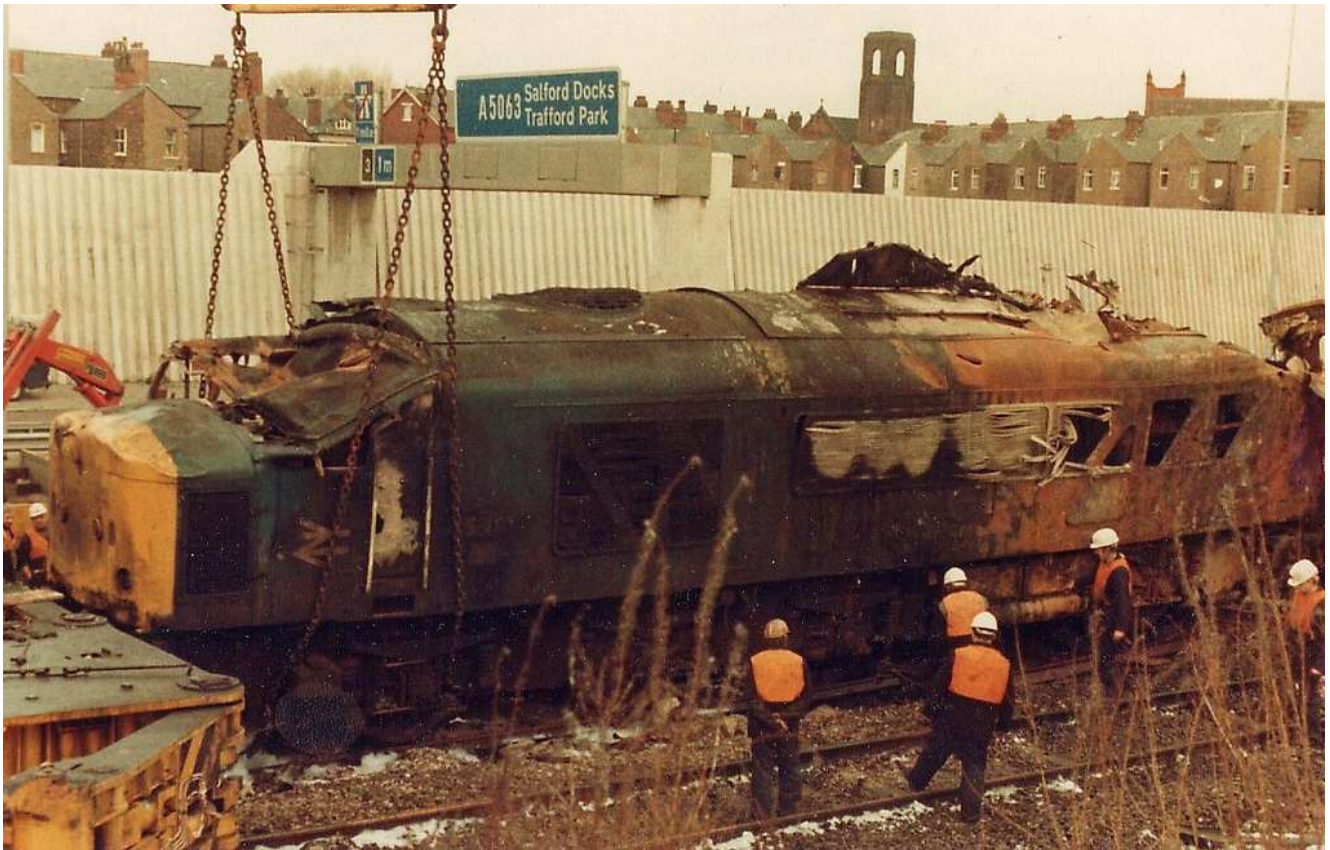
Above: Recovery of 45147 taking place on Wednesday 5th December. This photo shows the extensive fire damaged and the crushed rear No.1 end cab. Photo: F J Bullock

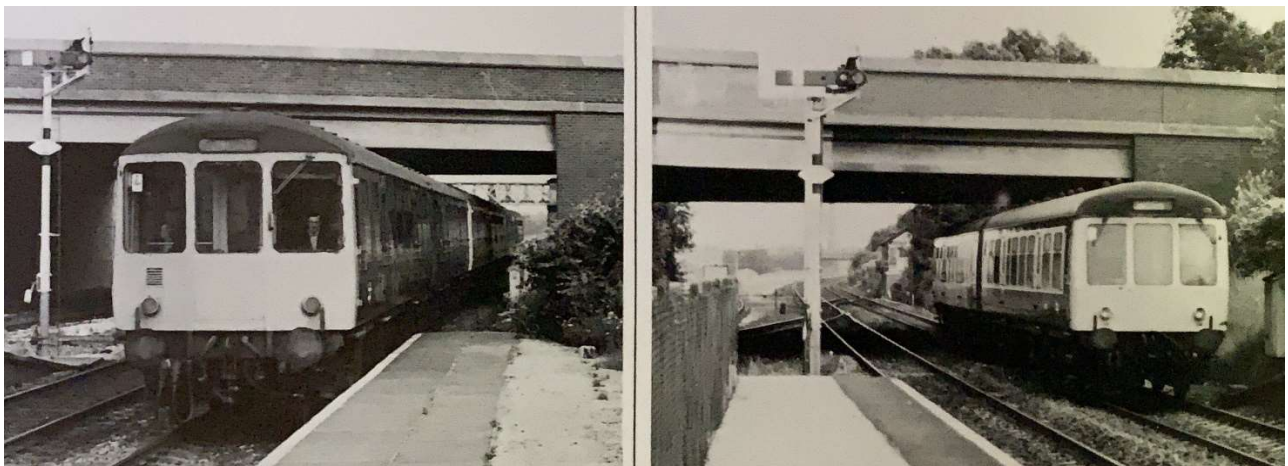
The Eccles signalman, signalling equipment and train brakes were all found blameless for the accident and it was concluded that the driver simply missed the signals protecting the oil train (there was no AWS fitted to the signal at that time).

During the investigation it was noted that the semaphore ES50 signal, which was passed at danger by 45147, had poor sighting. When the signal arm was in the horizontal (danger) position, it was difficult to see against the background of a recently constructed overbridge built in red brick. The signal was subsequently fitted with a white background.

The semaphore Eccles ES50 signal pictured before the crash (left), showing the poor sighting against the bridge in the background, and after the crash (right) when it had been fitted with a white background. Eccles signal box can be seen beyond the bridge in the right hand picture.

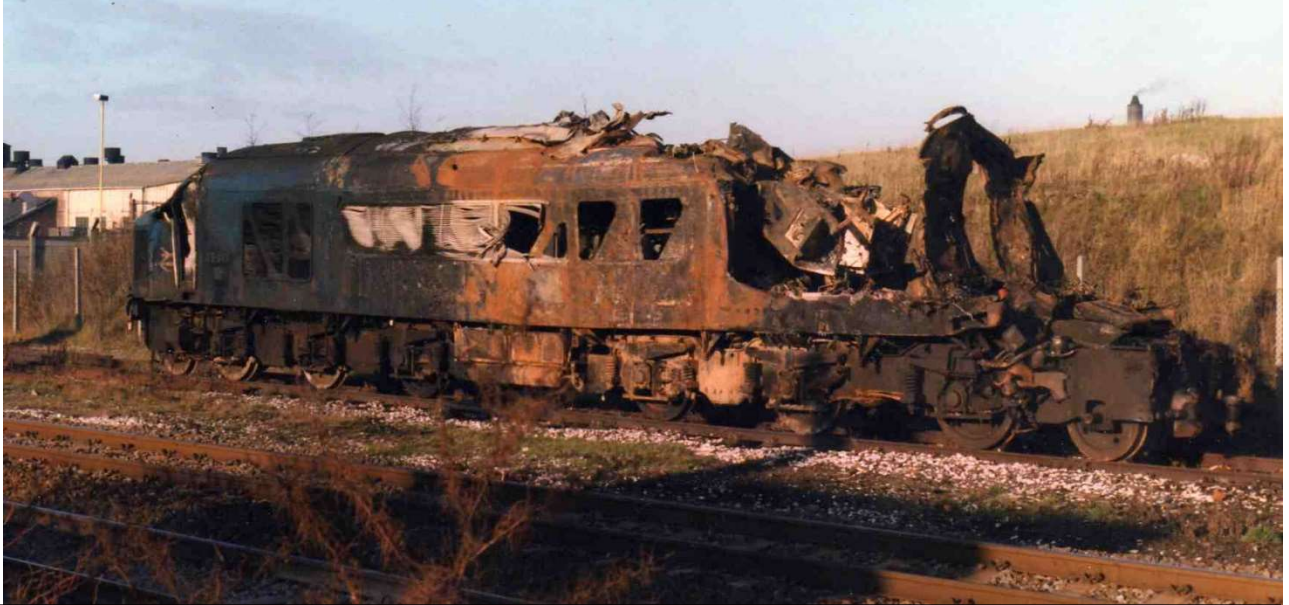
45147 was the last damaged vehicle to be removed from the crash site, being rerailed on Wednesday 5th December. The fact that the bogies were badly damaged and the bodysides out of gauge meant that it was not fit to travel far by rail, so it was towed just one mile to a siding near Patricroft to await its fate. It was officially withdrawn on 4th January 1985 and remained at Patricroft until the first week of March 1985 when it was cut up on site by Vic Berrys Ltd.

The remains of 45147 in a siding just west of Patricroft station, where it was recovered to the day after the accident and stayed there until cut up in the first week of March 1985. The loco was initially sheeted over, but the covers quite quickly disappeared. The fact that the loco was in left in full view from the adjacent Liverpool – Manchester main line for 3 months was quite surprising.

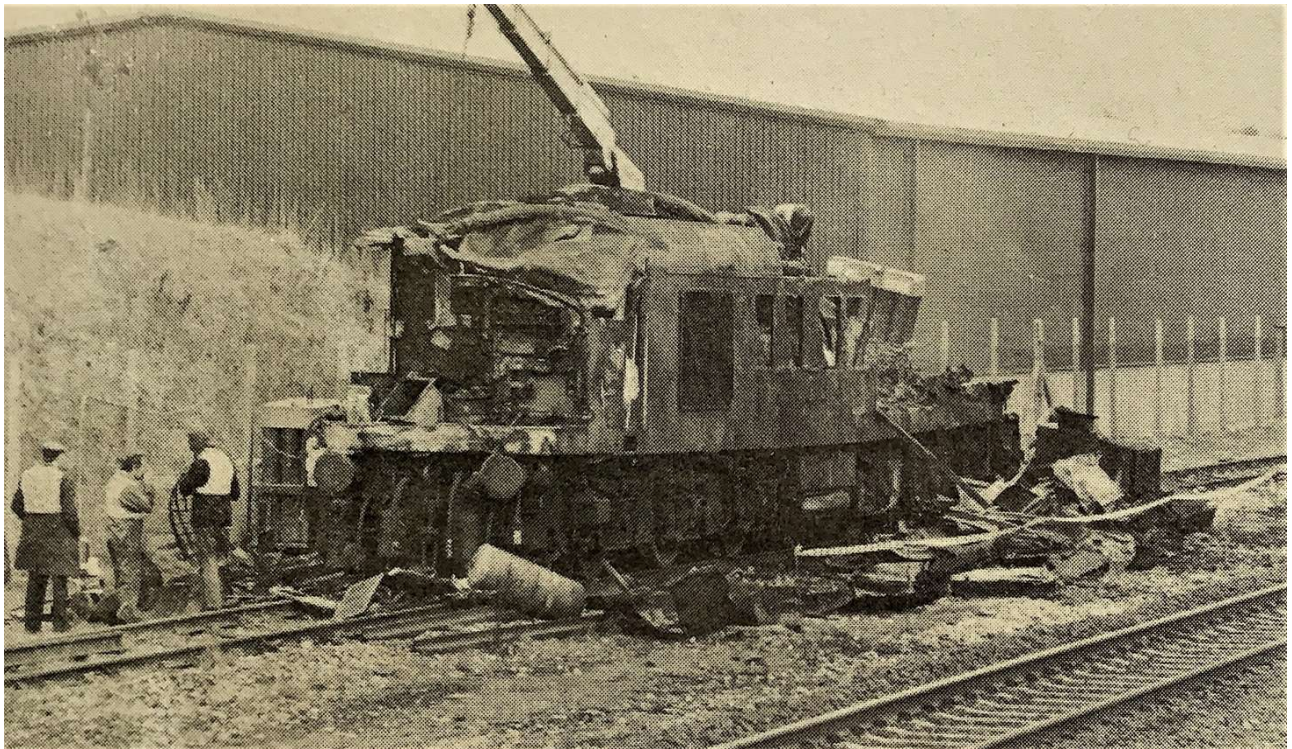
45147 being cut up on site at Patricroft by Vic Berrys Ltd during the first week of March 1985. Photo: J. A Oldfield.
