Article – D94 (45114) Accident at Stanton Gate 06/12/63

(Photos were all taken by Mr Neville Berry and are reproduced by kind permission of his grandson, Andrew)

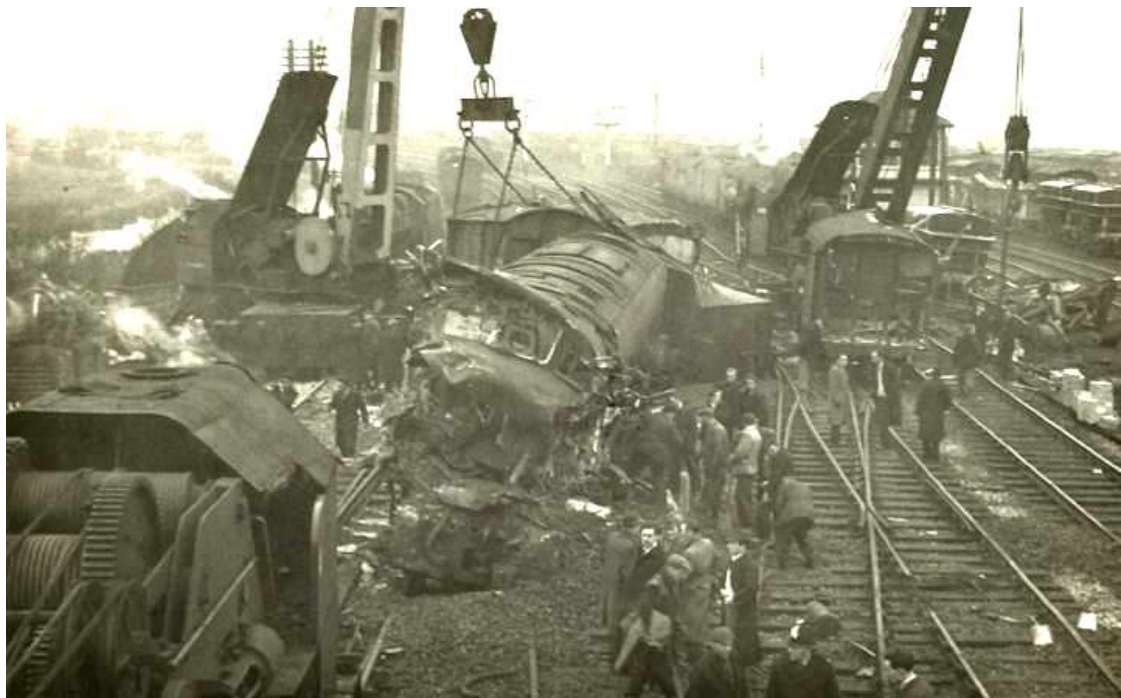
D94 was recovered from the crash site and moved to Derby Works for repair. It was displayed in ex-works condition at the works open day on 28/08/64, before being released back to traffic. In 1967 it underwent a refurbishment, during which the split headcode boxes were replaced with a one piece centre head code boxes and the lower body side triangular access panels replaced with grilles.
