## **Article – D94 (45114) Accident at Stanton Gate 06/12/63**

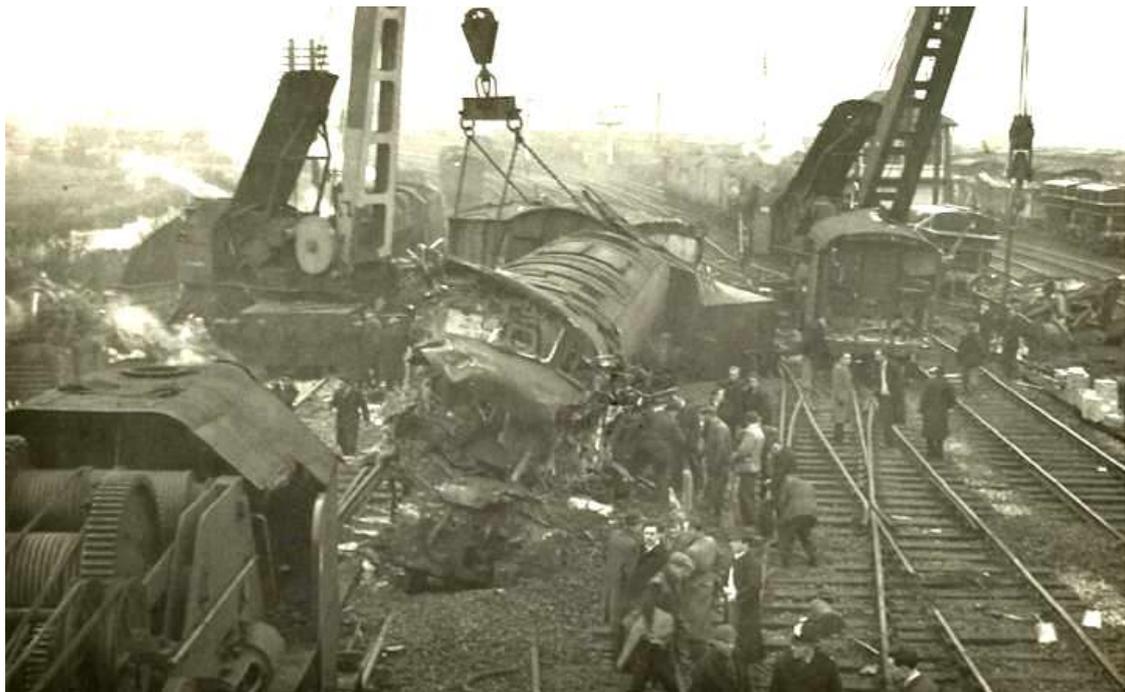
D94 was recovered from the crash site and moved to Derby Works. During rebuilding, the original split box head codes were replaced at No.2 end with a one piece centre head code box. It was displayed in ex-works condition at Derby Works Open day on 28/08/64, before being released back to traffic. In 1967 it underwent a refurbishment, the No.1 end head code boxes were replaced to match the other end and the lower body side triangular access panels replaced with grilles.

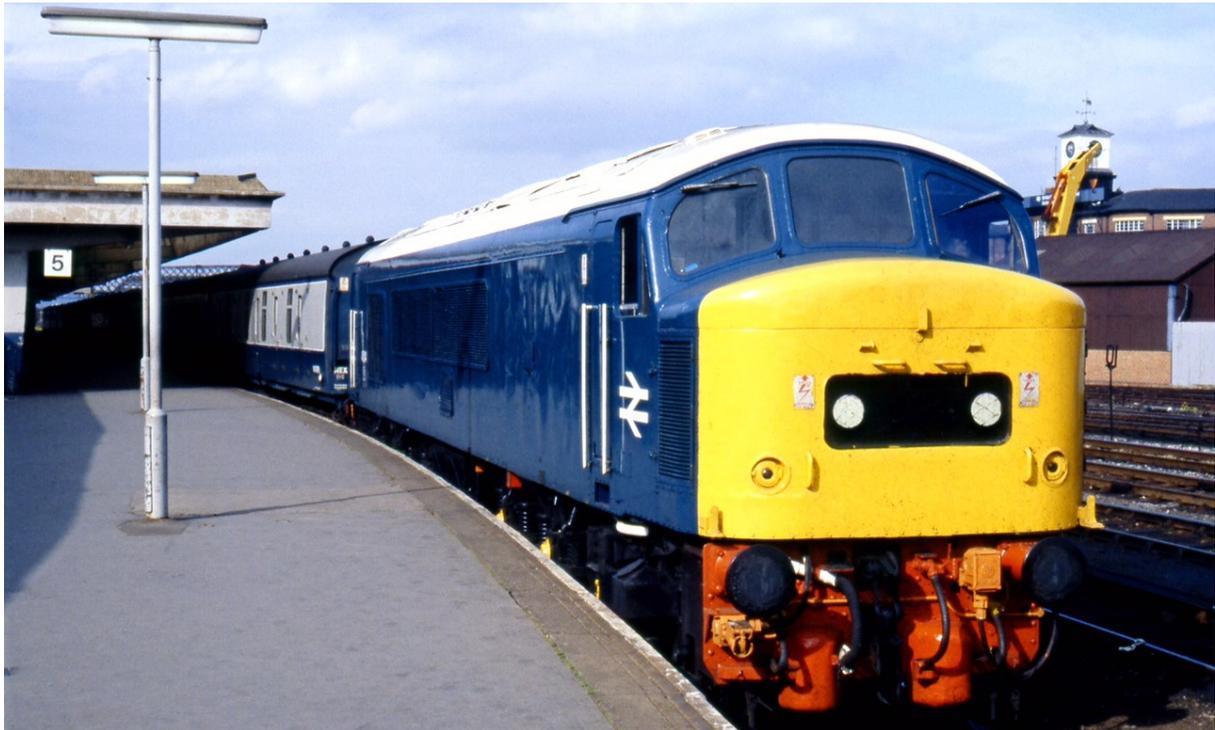
*45114 sporting a white roof and red bufferbeams at Derby on 17/09/79.*
