45014 – Chinley Accident – by Steve Dexter

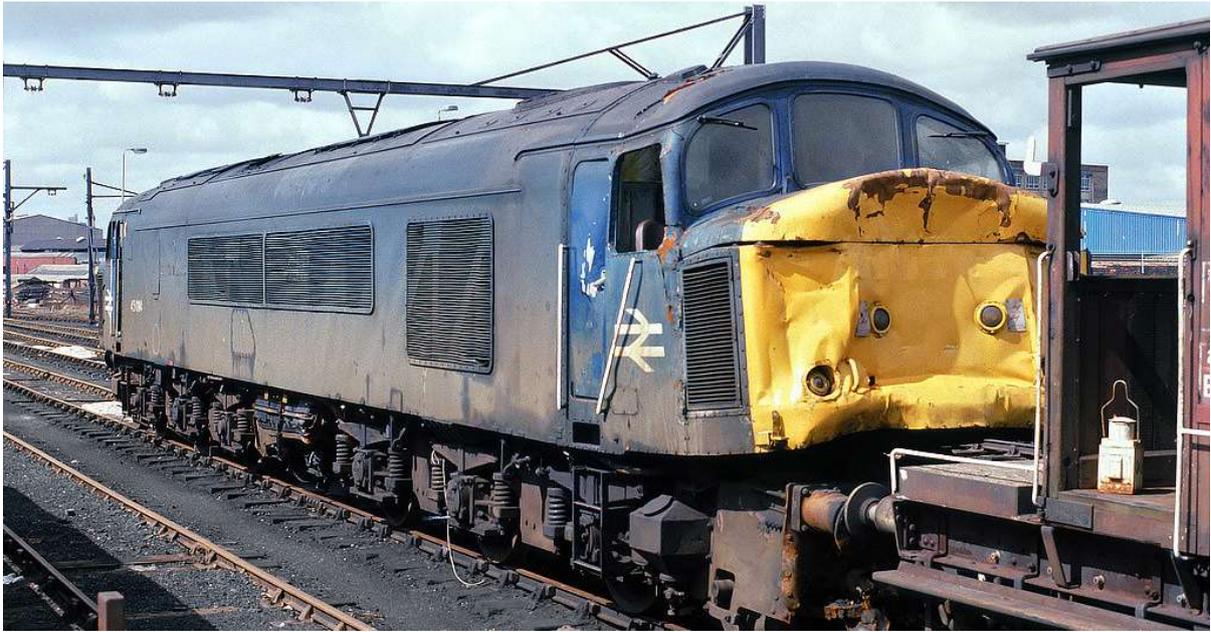
*45014 at Ashburys on 20/04/86, showing the damage to No.1 end caused by the impact with 31436.
Photo: Terry Eyres*

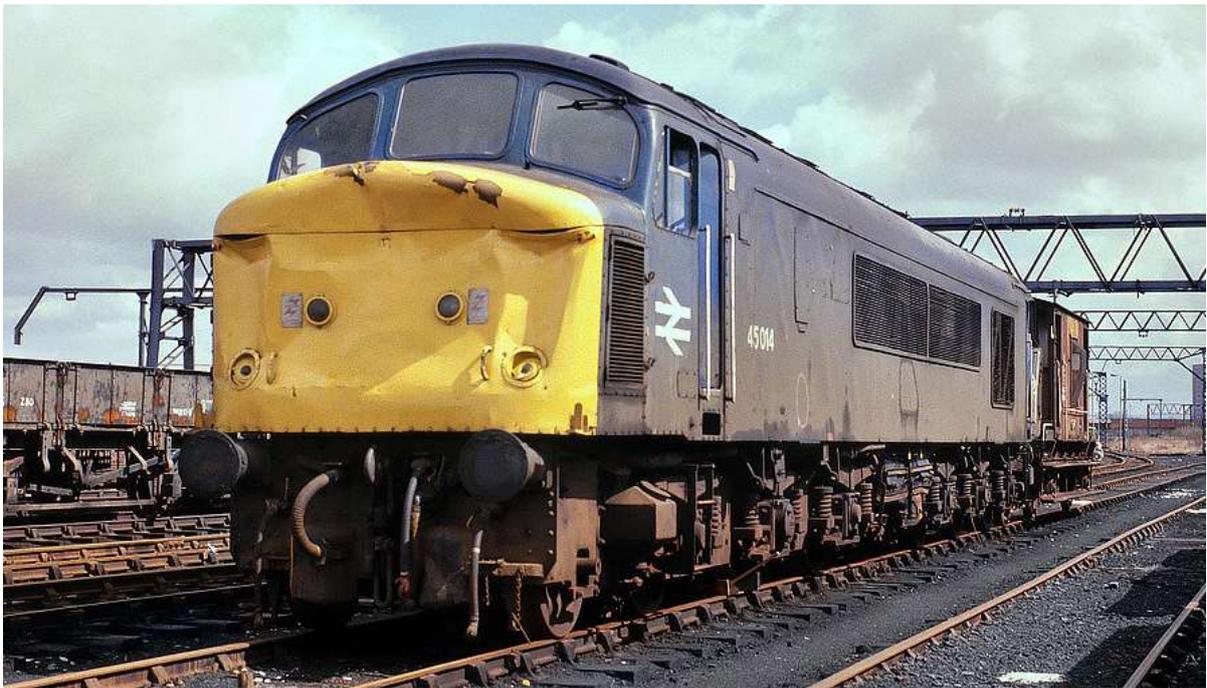
45014 at Ashburys on 20/04/86, showing the damage to No.2 end caused by the impact with 47334 that was coupled behind the peak when the collision occurred. Photo: Terry Eyres

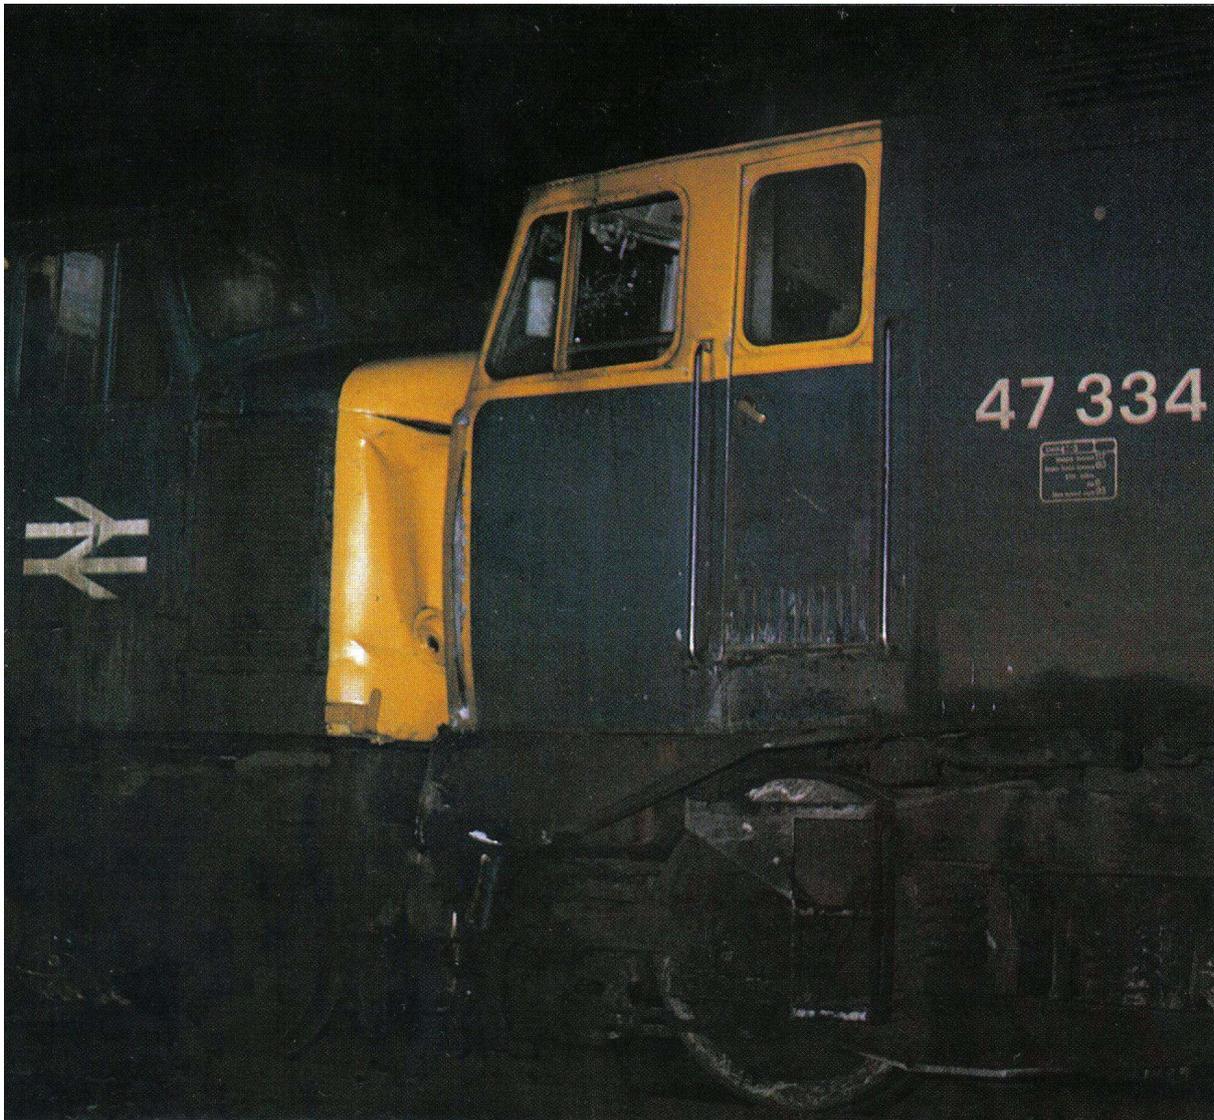
Photo taken just after the collision, showing the No.2 end of 45014 locked onto 47334 after the buffers on the 47 sheared off and the nose of the peak impacted the cab of the loco it was coupled to.

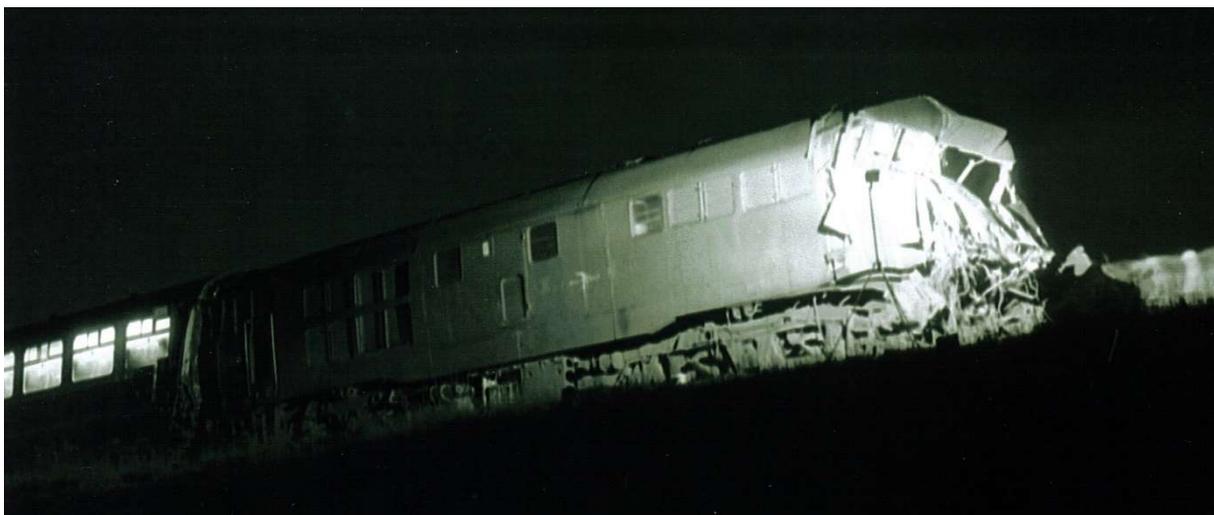
31436 had fared much worse, with the No.2 cab crushed back to the engine room bulkhead and the floor and underframe rolled back underneath the loco. The leading bogie was badly

buckled and two axles derailed. The No.1 end cab was damaged from impact with the end of the leading coach. Regrettably the driver of 31436 was killed and 32 passengers were taken to hospital. The driver of 45014 was commended for his actions in reducing the impact of the collision by staying at the controls to release the brakes and put the locos into reverse.

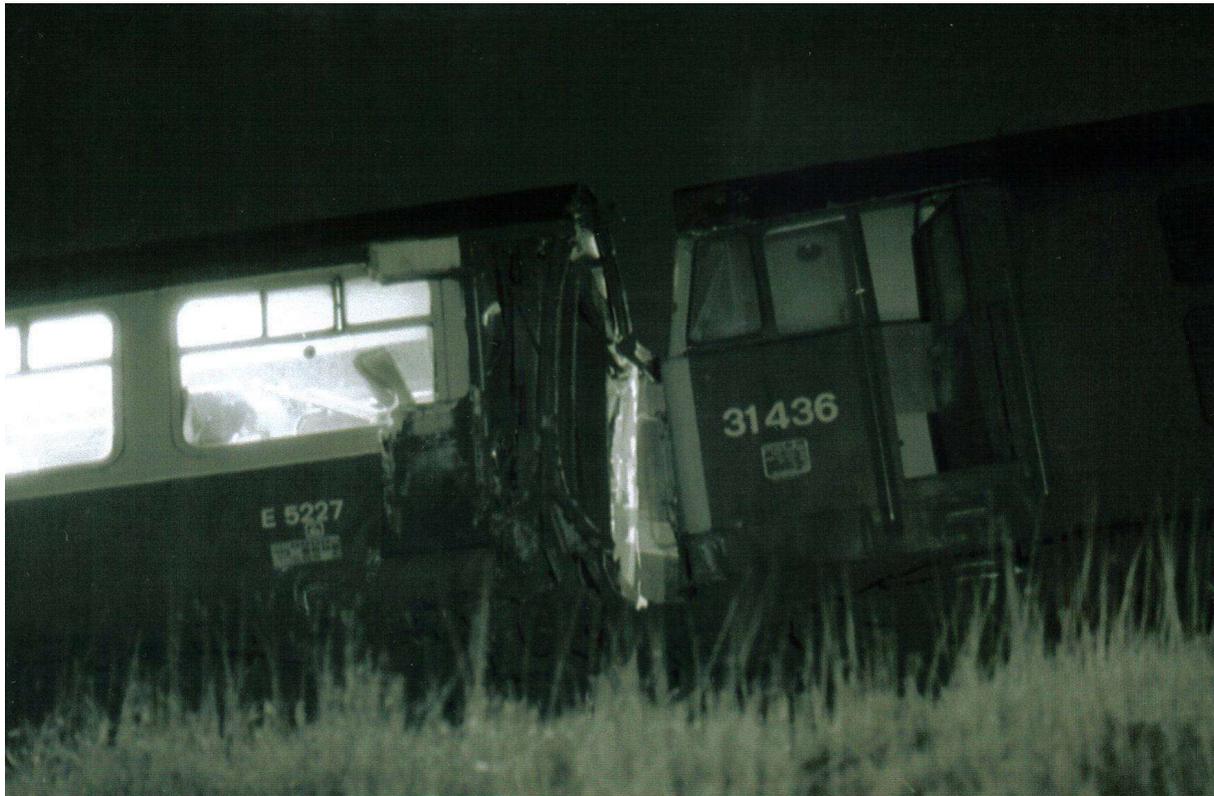
Photo taken just after the collision, showing how the leading coach of 1M42 impacted on the trailing cab of 31436 at the time of the collision with 45014. Two photos above by Roger Kaye

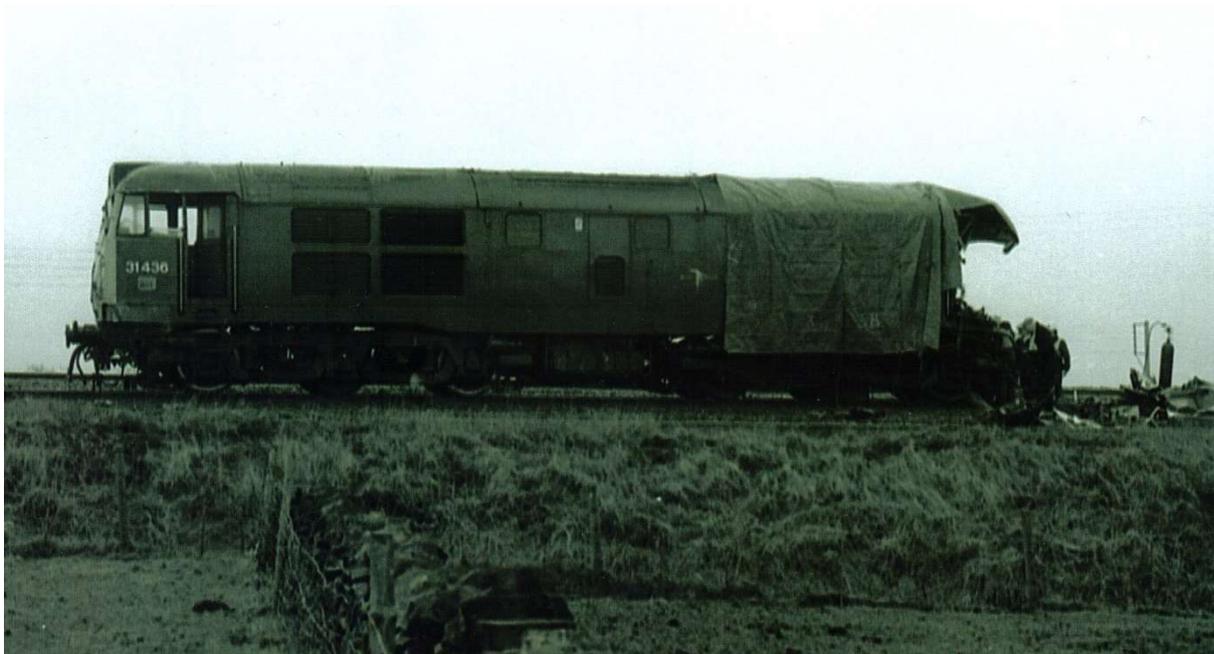
Photo taken the day after the collision, showing 31436 being prepared for movement to Edale. Photo Roger Kaye

Recovery operations continued through the night and the following day, with 45014 towed back to New Mills South Jn Up Goods Loop and 31436 to the Down Loop at Edale. 47334 was despatched straight to Crewe Works for repair.

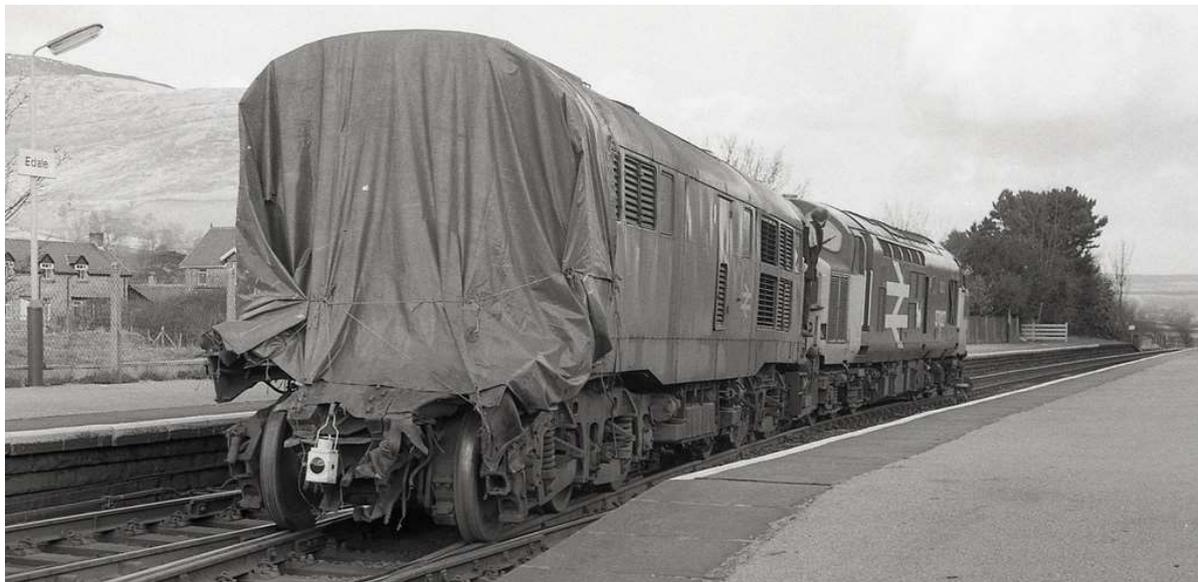
37027 recovering 31436 from Edale to Doncaster Works on 04/04/86

Of the other locos involved, 31436 was recovered from Edale on 4th April 1986 by 37027 and hauled to Doncaster Works for assessment. It was officially withdrawn on 15th October 1986 and was cut up by the following January. The ETH components were recovered and used to convert a replacement Class 31 into No.31469.

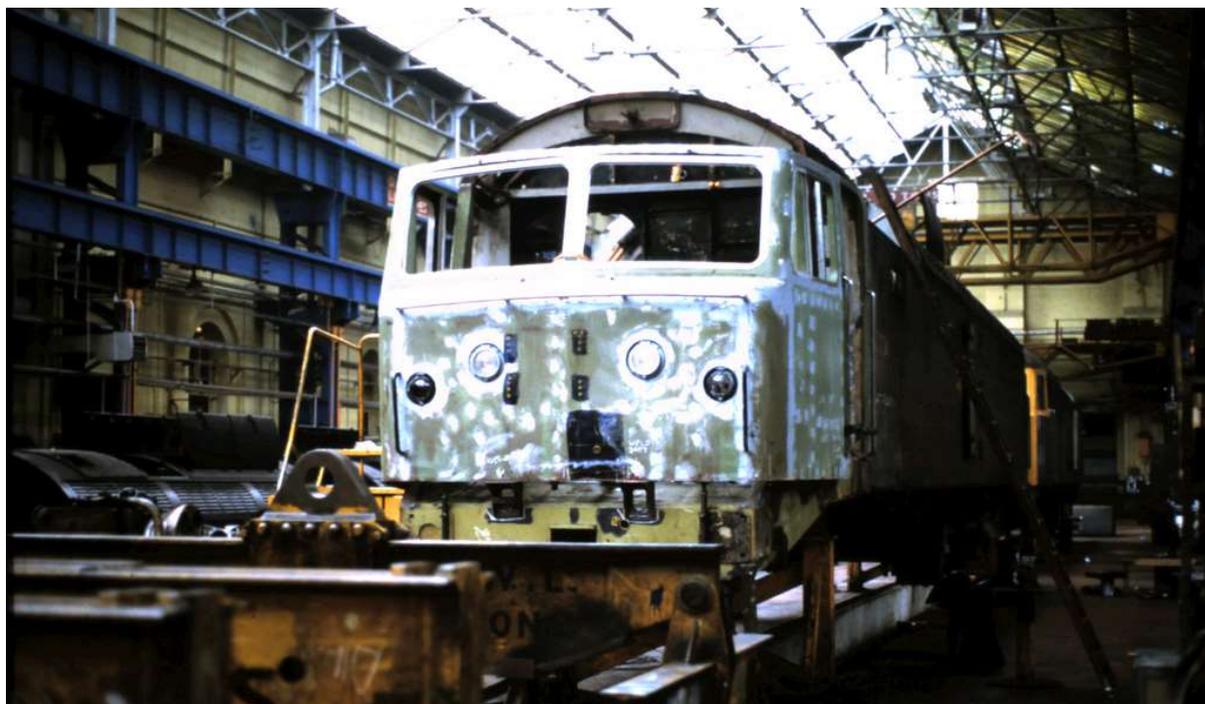
47334 being fitted with a new cab in Crewe Works in summer 1986. Photo: Johnnie Simmonds

47334 was fitted with a new cab and released from Crewe Works in October 1986. Latterly it was operated by Freightliner, being retired in 2001 and scrapped at Booths in Rotherham in December 2004.
